Subject: Approval to Increase the Annual Payment KCC Makes to the District from \$29,000 Per Year to \$29,696 Per Year As Authorized In 2.2 of the Contract

**AGREEMENT BETWEEN THE KENSINGTON POLICE PROTECTION
AND COMMUNITY SERVICES DISTRICT AND THE KENSINGTON
COMMUNITY COUNCIL REGARDING RECREATIONAL AND
EDUCATIONAL PROGRAM SERVICES**

3.1. The District has obtained a report from Cantor Inspections dated April 26, 2023, that details conditions in the Recreation Building that require significant maintenance and repair (“Cantor Report”). A copy of the Cantor Report is set forth in Exhibit in E.

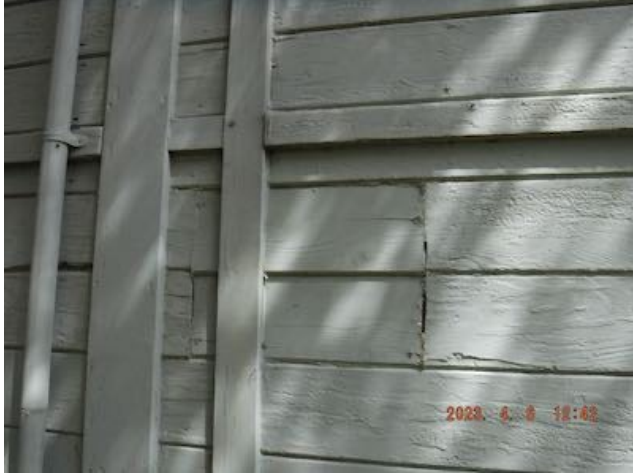
This building has horizontal wood siding. The siding shows moderate wear. Moderate damage was seen in a few places, but none was deemed significant. This was mostly in the form of improperly staggered cuts that are likely to have been access panels or poor repairs. See an example below.

We recommend that these areas be properly nailed and filled prior to painting.

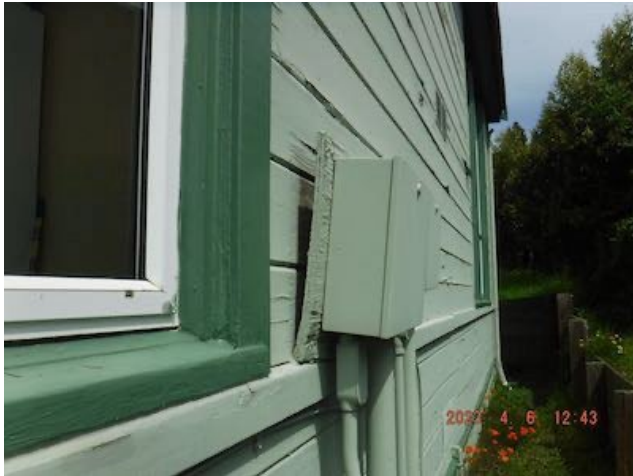
Low voltage electrical equipment is mounted on the left-hand side of the building using a plywood panel which has become loose from the siding.

This has only a very minor effect on the building itself and should be referred to the installer or maintenance parties related to the low voltage equipment.

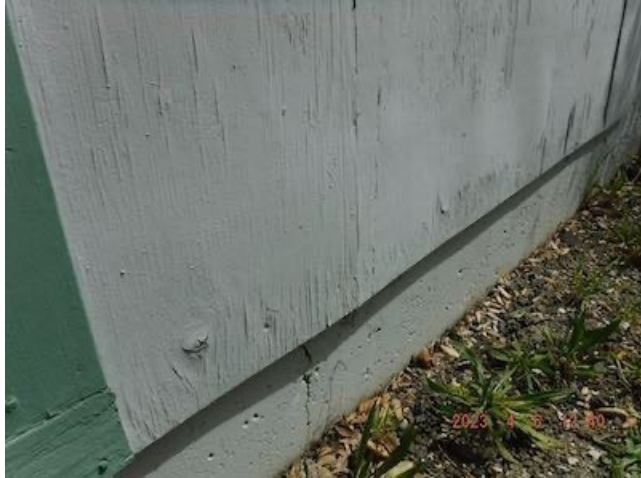
Plywood Siding

There is plywood siding at the building skirt, mostly at the rear. This siding shows moderate wear with some localized damage. See this below.

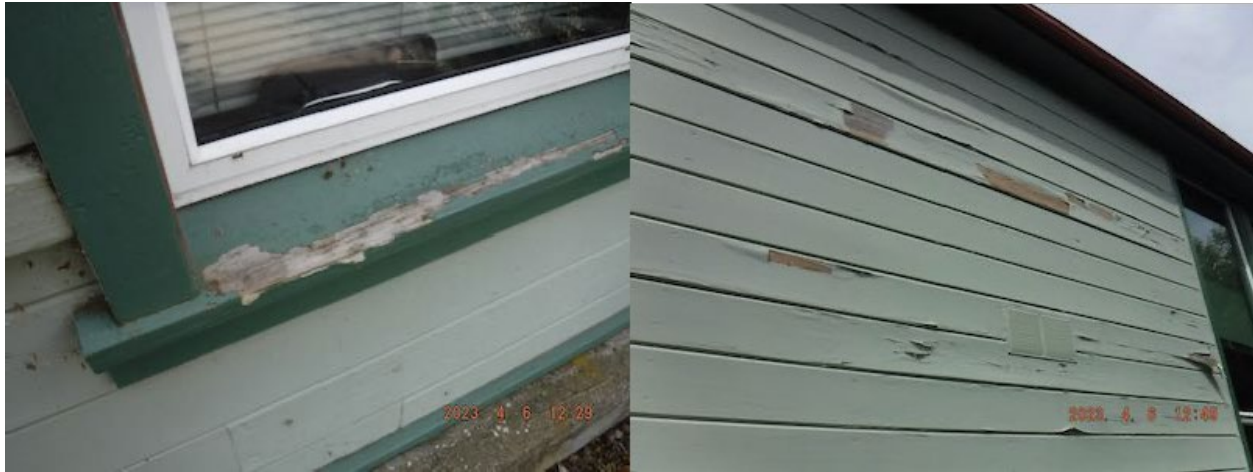
Paint

The paint is peeling on the siding and trim in several places. We recommend the peeling paint be scraped, sanded, caulked, primed, and painted as needed by a qualified painting contractor.

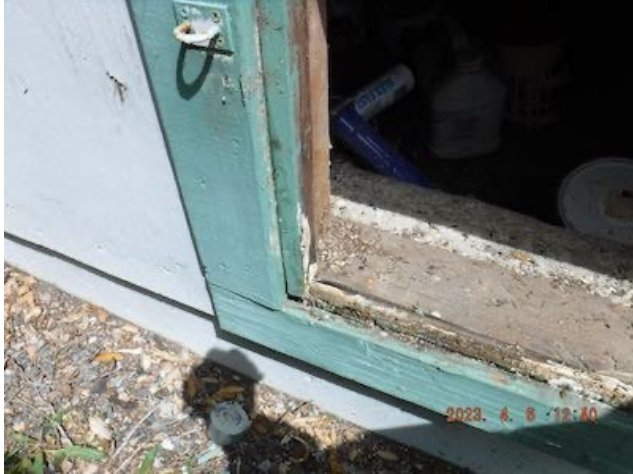
The trim is damaged in a few places. See some of this, below, around one of the two crawlspace openings at the rear.

We recommend the damaged trim be repaired or replaced as needed. None of this was highly critical.

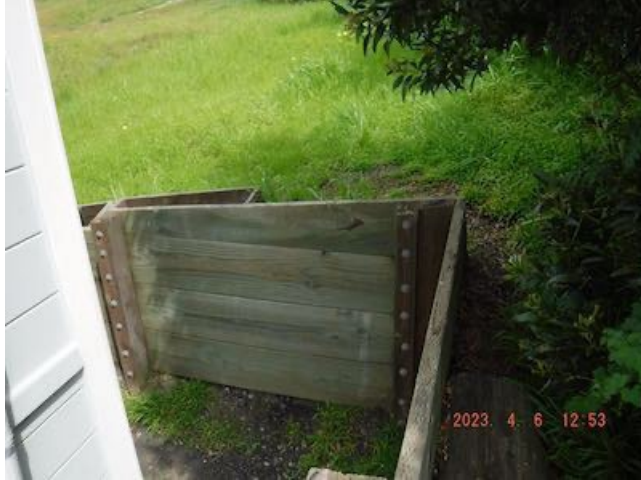
Retaining Walls

There are wooden retaining walls at the front/right. These walls are not provided with sufficient barriers or guardrails to prevent a fall. See below.

We recommend adequate safety barriers be installed.

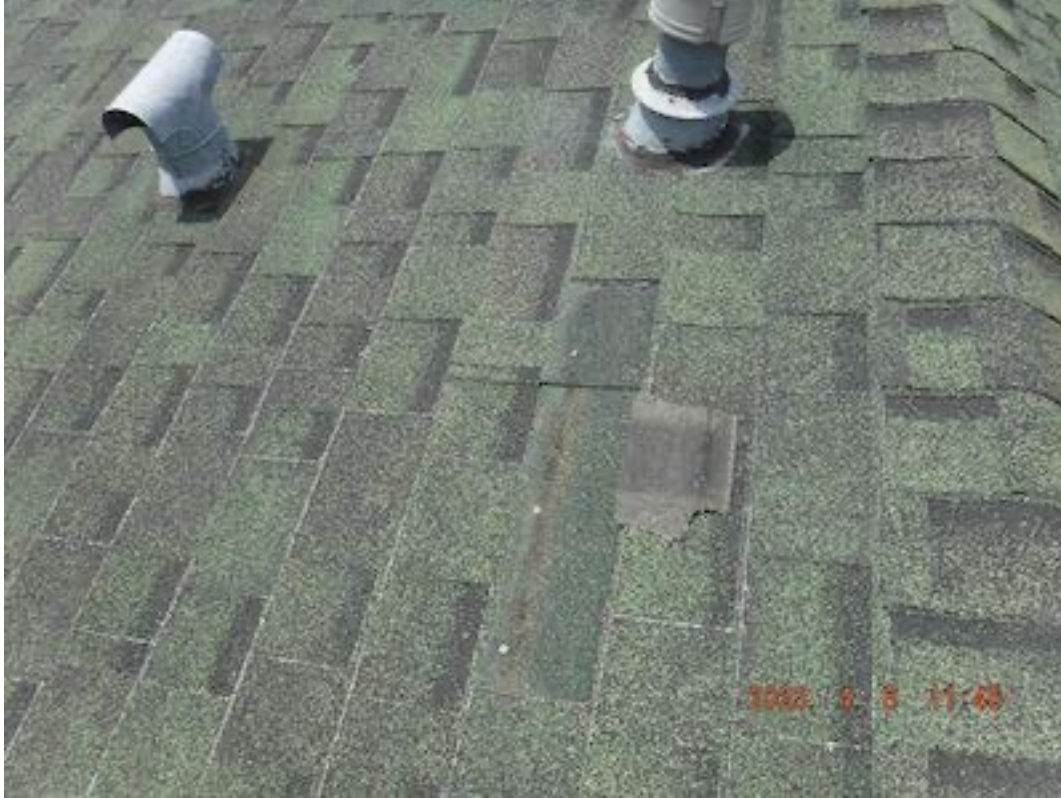
Roof Surface

The building has a laminated composition shingle roof, which is in very worn condition and damaged in several places. See the damage below.

There are several exposed fasteners. With time exposed fasteners will rust and loosen and may cause leakage.

The roofing shows evidence of numerous repairs and has been extensively patched in several places, likely indicating previous roof leakage.

We recommend a new roof surface be installed.

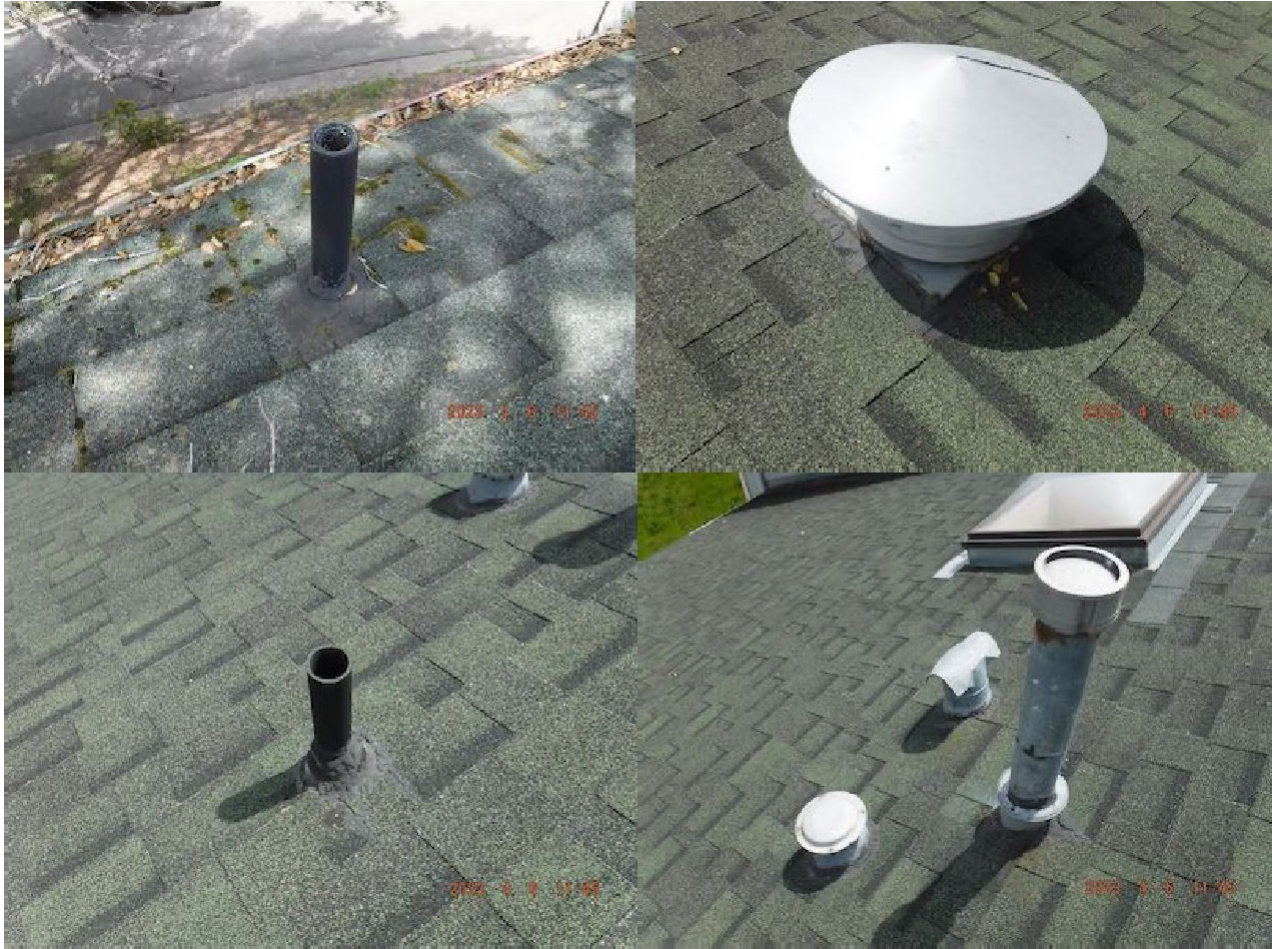
Several of the piping penetrations lack proper flashings and rely upon mastic predominately. See below.

We recommend that all of the flashings be replaced with the new roof.

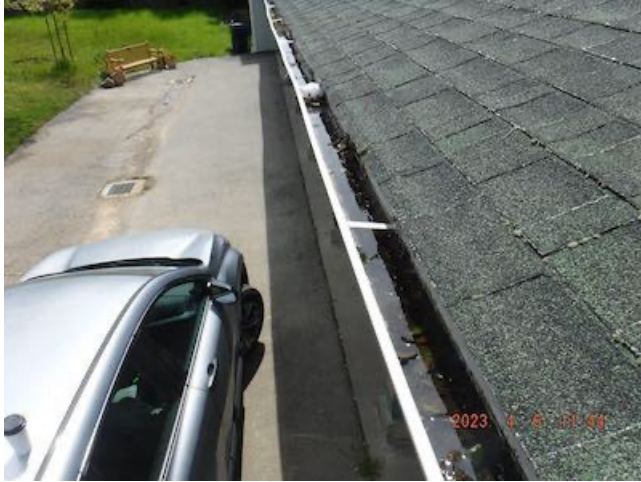
The roof has sheet metal rain gutters. They show moderate wear.

Debris has accumulated densely in several places in the gutters. There are signs of previous standing water in several places.

We recommend the gutters be cleaned and re-examined, and modified as needed to drain freely. Rain gutters should be cleared periodically as part of routine maintenance.

We recommend strainers be installed in the gutters to minimize clogging by debris.

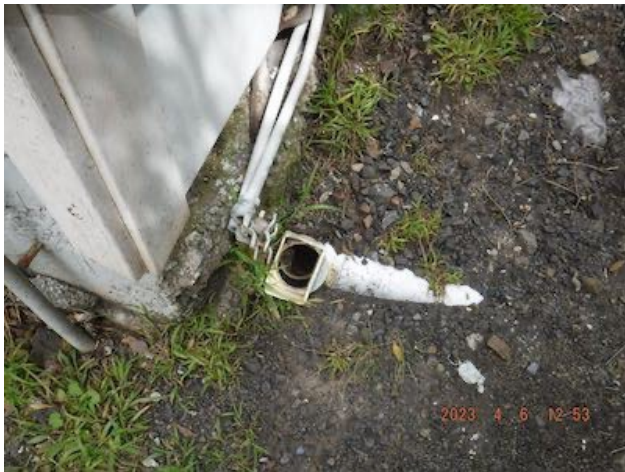
Several downspouts are damaged. We recommend the damaged downspouts be repaired or replaced as needed.

Several downspouts are disconnected at the top or bottom and we recommend repair.

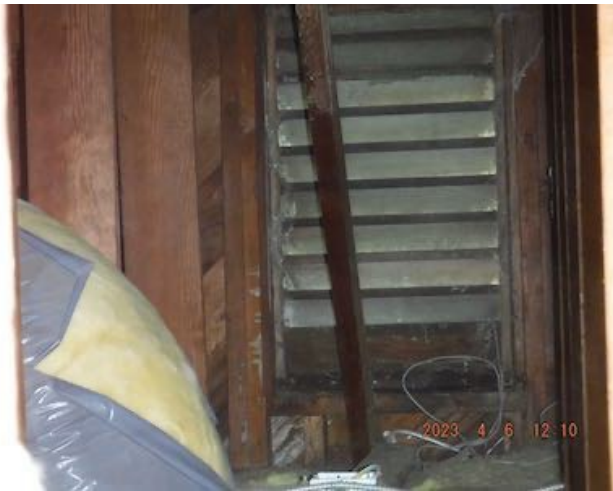
Several attic vents are not screened.

We recommend the vents be screened to prevent animal entry.

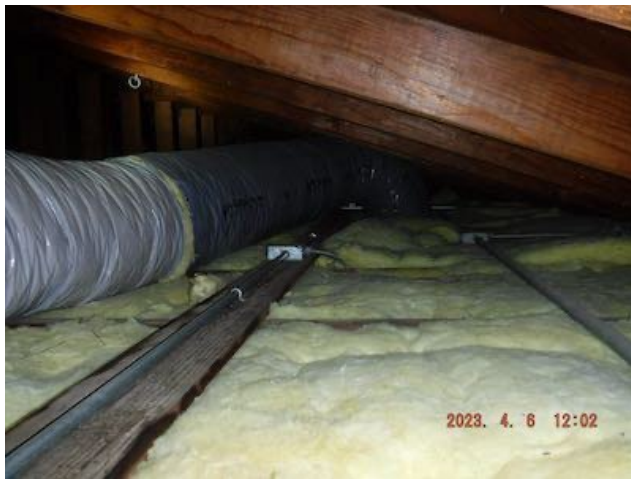
The attic is insulated with fiberglass batts that are approximately 4 to 7 inches thick.

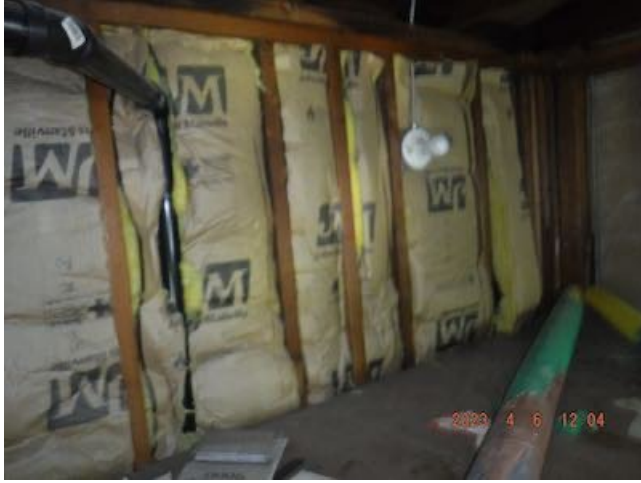
The insulation in the attic vestibules near the furnace has been installed reversed with the paper backing facing the open space. See an example below.

Inverted vapor barriers can constitute a fire hazard. A warning to this effect is typically found on the insulation vapor barrier. The vapor barrier should be placed against a solid backing, toward the interior of the dwelling and should never be visible from the crawlspace or the attic. In humid environments, this inversion can also cause the accrual of condensation and can damage framing. We recommend vapor barriers be properly placed.

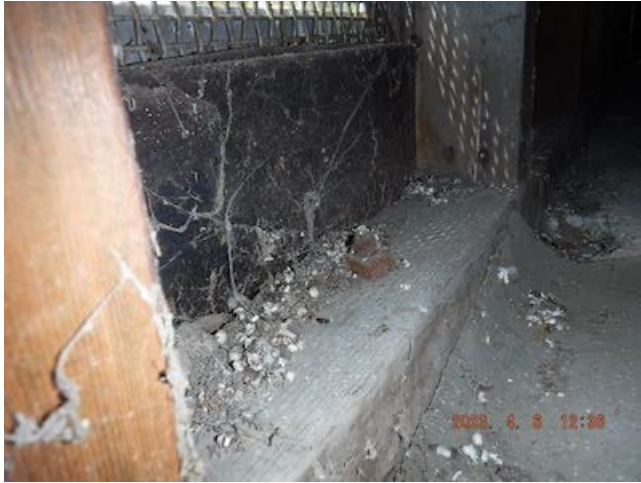
The foundation is equipped with a few, small, rusty anchor bolts. See one below.

As a rule, foundation bolts installed in most of the 20th century fall short of the strength mandated by engineers when seismic retrofitting is done. Currently engineers will typically call for a larger number of bolts (more per linear foot of foundation), larger bolts, improved washers and well tightened bolting. It is also clear that rusting of non-galvanized bolting, which is the kind used in nearly all foundations, leads to weakening over just a few decades and they can lose much of their strength after many decades. Older bolts should be replaced by new, improved bolting in all houses located near major fault lines.

We recommend additional anchor bolts be installed as needed by a qualified contractor.

We recommend a qualified engineer be retained to design or specify seismic upgrades appropriate for this building.

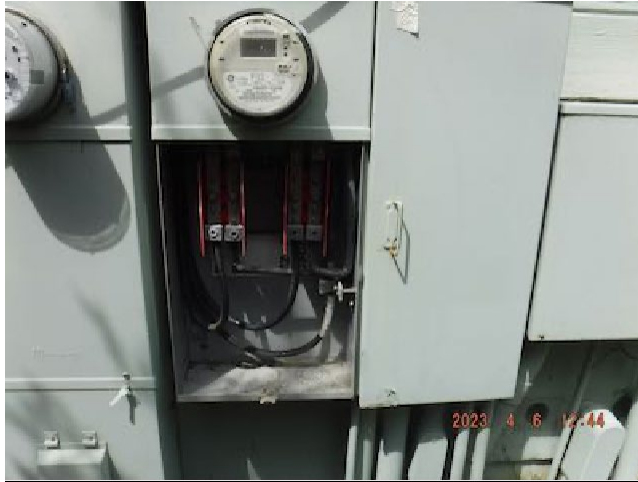
One of the panels in this main service assembly is not designed to be open by users and contains exposed hot terminals that could kill if opened by nonprofessionals. We urge that this panel be repaired for security immediately. See this below.

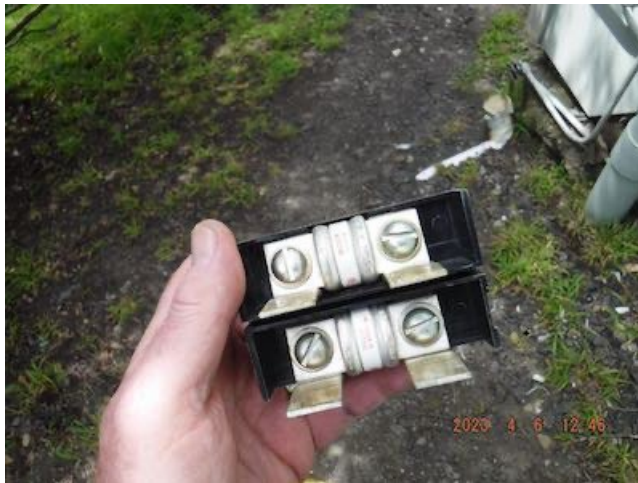
There is both a breaker main panel and a fuse main panel at the left exterior. Fuses in the latter panel are used for high voltage protection, as opposed the more outdated fuses of panels from the 1940 and earlier. The use of fuses (T type 200 amp shown below) in this case is not a concern for us, though more modern equipment will generally use solely breakers and add convenience.

The assembly of panels is damaged in several places, and we recommend repair or replacement by a qualified electrician. The panels also appear to be worn past a reasonable point of repair and maintenance and we suggest replacement of the entire assembly.

The left panel is in very worn condition, damaged in several places, and will soon need replacement. We recommend the left main panel be repaired or replaced by a qualified electrician.

The right fuse panel is very rusty and we recommend it be replaced.

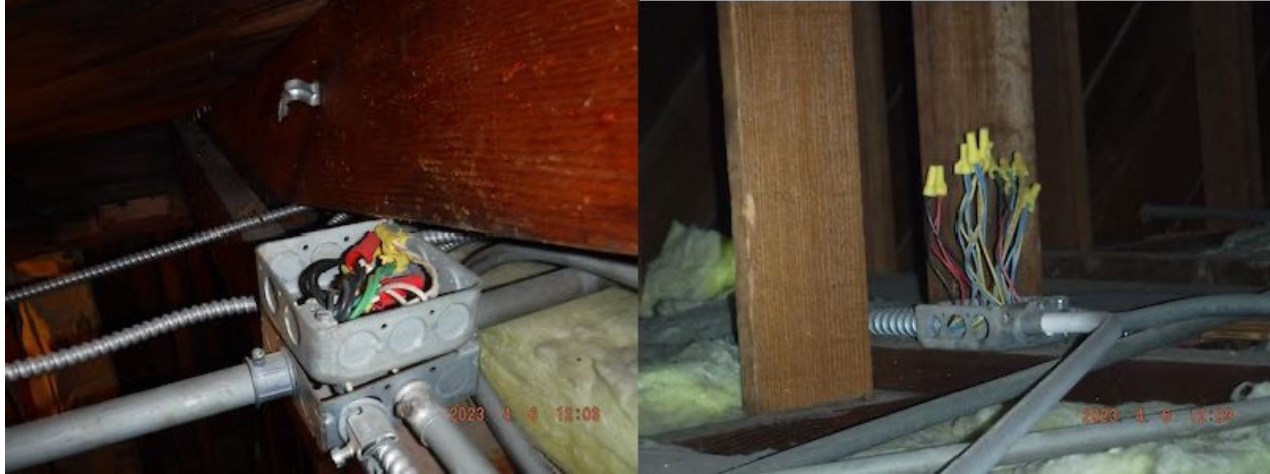
Several attic area electrical boxes are uncovered. We recommend box covers be installed as needed in the subfloor area. See two below.

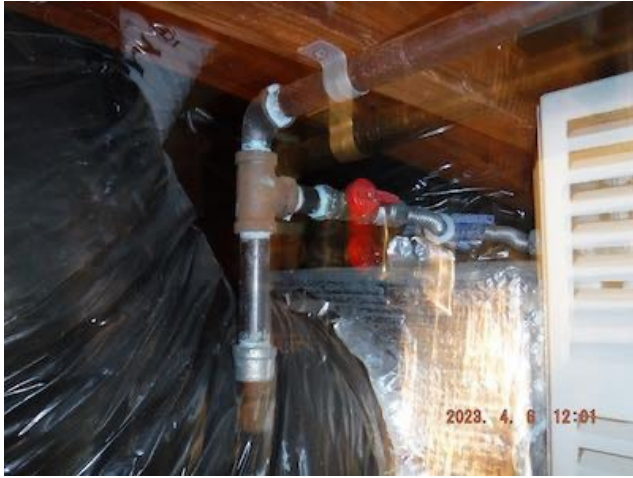
The sediment trap is installed before the gas valve instead of after and we recommend it be properly installed. This helps to deliver dry gas and prevent gas appliance failure. See this below.

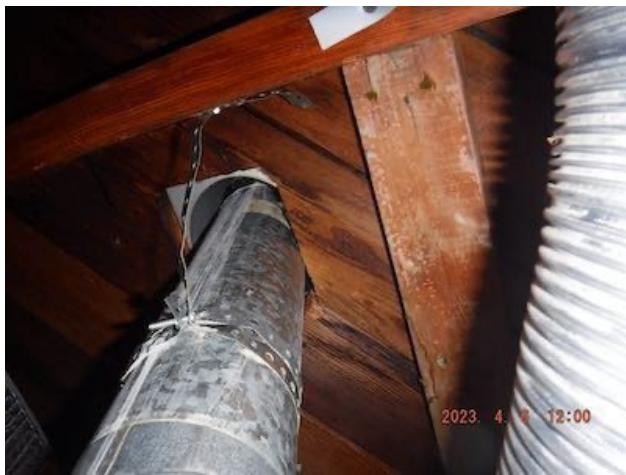
The double-wall vent piping is too close to roof sheathing and insulation, which is a potential fire hazard. See below.

We recommend adequate vent pipe clearance be provided. Double-wall vent pipes need at least 1-inch clearance from combustibles.

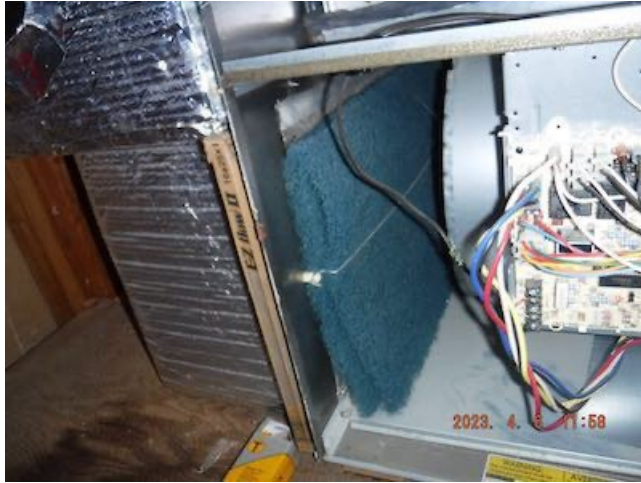
There is also a separate filter to the left of the unit and this lacks a proper filter cover as required. We recommend that a proper filter cover be installed by a qualified heating contractor.

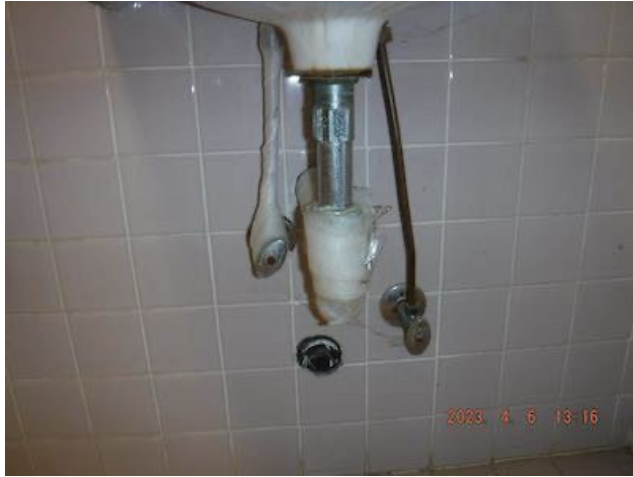
The ADA sink protection is incomplete in this bath. This can allow for scalding of some individuals and we recommend review of this and all related ADA issues with a qualified expert/contractor. See below.

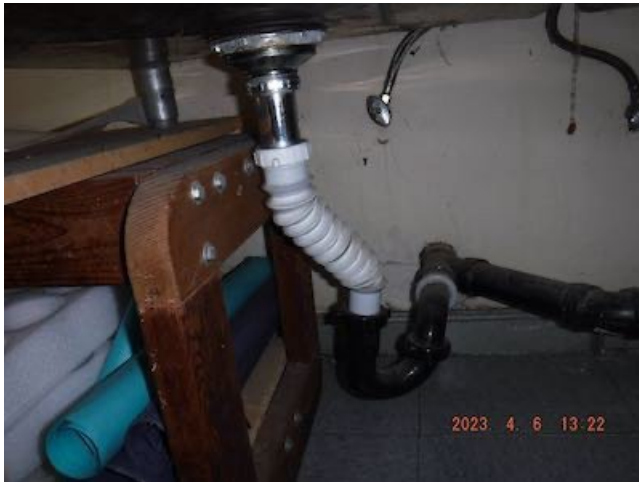
Art Sink

There is a stainless steel art sink in the main room at the rear. Flexible plastic waste piping is used at the sink drain and we recommend it be replaced with proper, smooth wall drain piping.

Corrugated drainage connectors are often installed by non-professionals to form drain traps or other drainage connections. These materials do not have smooth interior waterways and collect sludge. They are not approved and should be replaced with conventional drainage fittings and materials.
