Kensington Community Services District

SUBJECT: Discussion and Direction Regarding Use of the Annex Building

A bit of a background on the Annex Building. Upon my arrival in 2023, the Annex Building was not in use and was a mess. I was told that the building was not usable but a report by an outside company, Cantor Inspections determined that was not the case. A follow-up of previous consultant reports regarding the Annex Building revealed no dangerous materials detrimental to using the building.

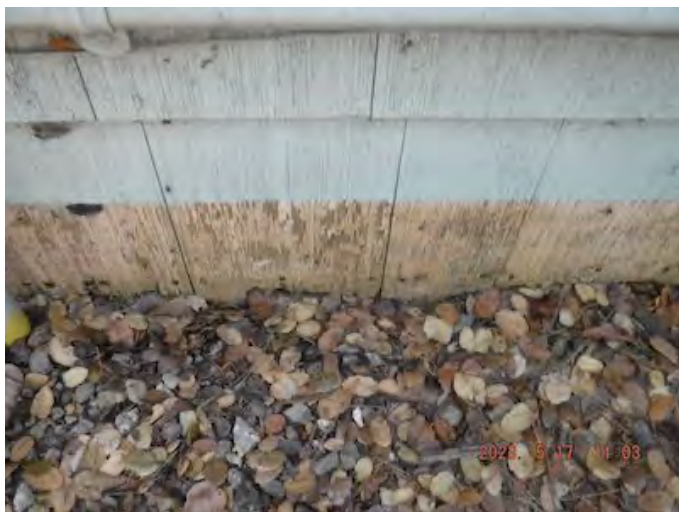
Wood siding in several places is embedded in the soil below. See below.

This condition can trap moisture in the wood and is conducive to decay. We recommend adequate clearance be provided as needed to eliminate embedded conditions.

There is wood-soil contact in several places. We recommend adequate wood-soil clearance be provided.

There is wood-soil contact in several places. We recommend adequate clearance be provided as needed to eliminate embedded conditions.

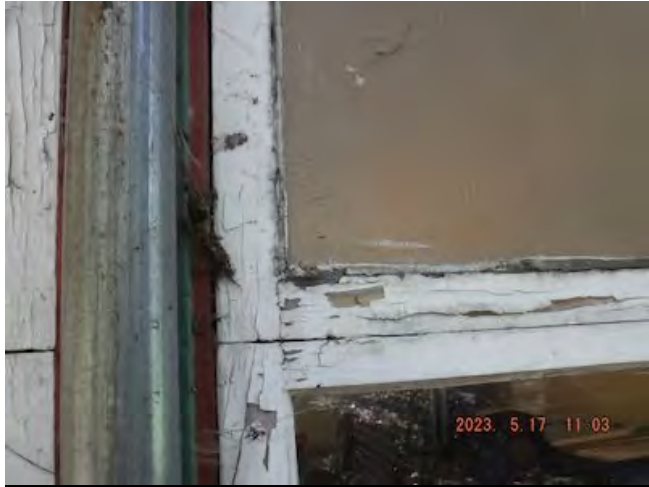
The exterior glazing putty is worn and missing in several places. We recommend new putty be installed as needed to protect the windows from moisture intrusion.

We recommend new putty be installed as needed to protect the windows from moisture intrusion.

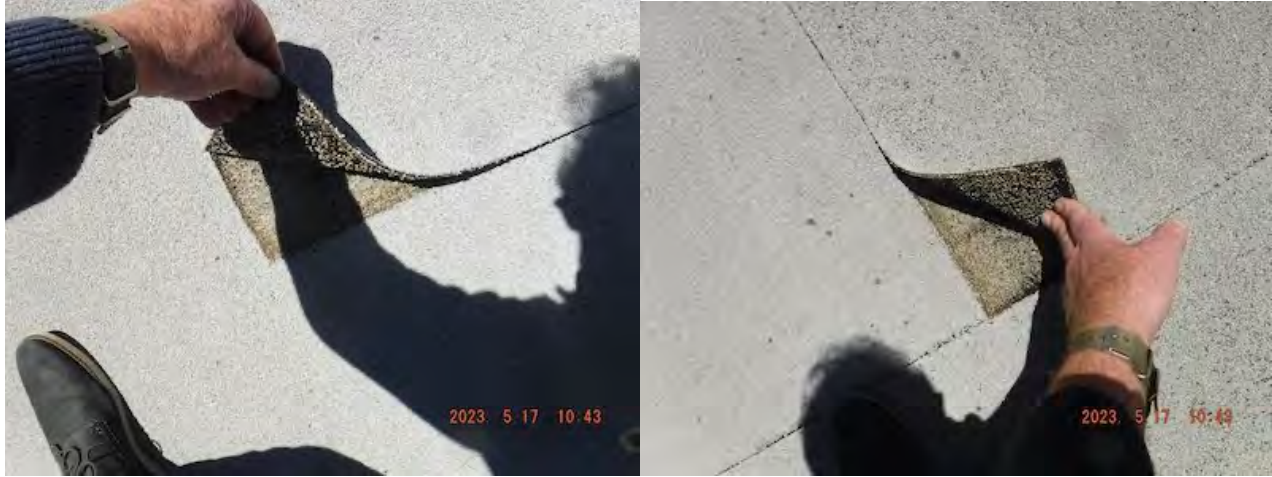
Several of the seams are not properly welded together. See two of these below.

This may be an adhesive type of modified bitumen and normal without the typical adhering bead resulting for adequate heating.

The roofing is loose in several places, and we recommend repair by a qualified roofer.

We recommend further inspection by a qualified roofer to determine the appropriate method of repair.

The roofing is loose in several places, and we recommend repair by a qualified roofer.

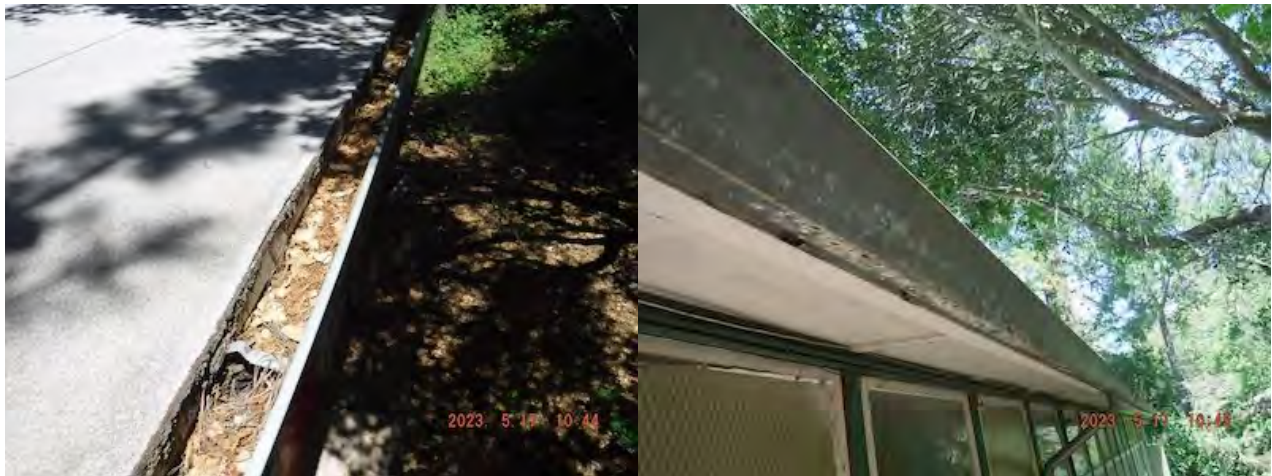
The roof has sheet metal rain gutters. They are in poor condition. We recommend the gutters be replaced. See below.

We recommend the gutters be replaced. We recommend all of the downspouts be replaced.

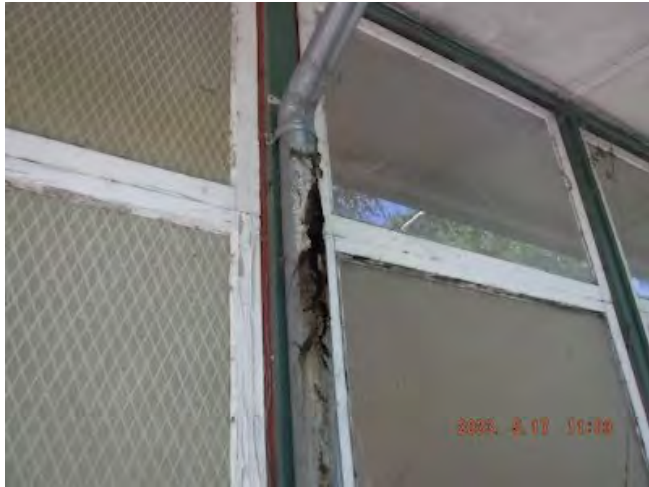
Several downspouts are damaged. See one below. We recommend all of the downspouts be replaced.

We recommend rain gutter downspouts be directed into subsurface drain lines.

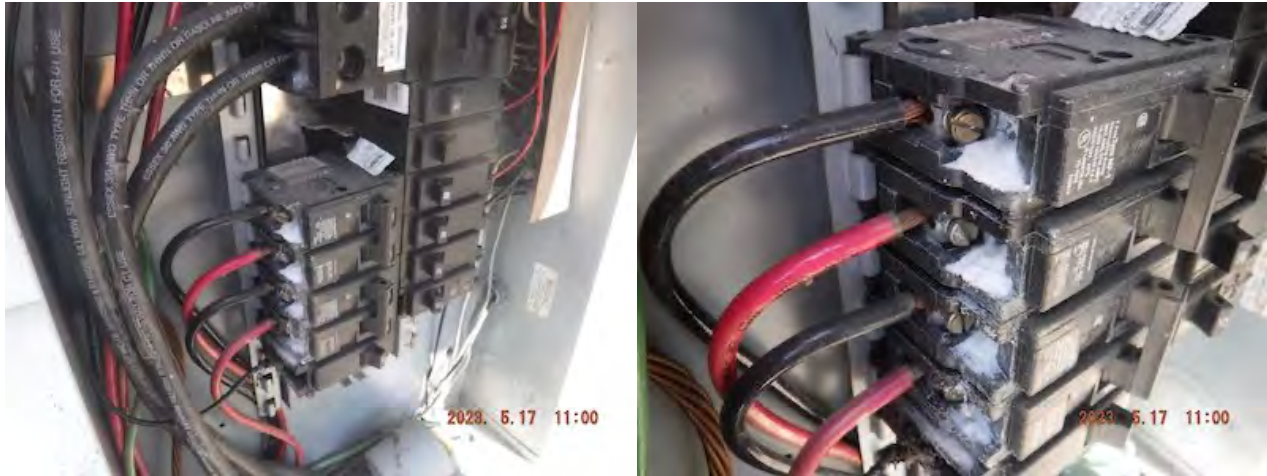
There is corrosion and built-up precipitate along the left side breakers, and we recommend repair or replacement by a qualified electrician. See this below.

There is corrosion and built-up precipitate along the left side breakers and we recommend repair or replacement by a qualified electrician.

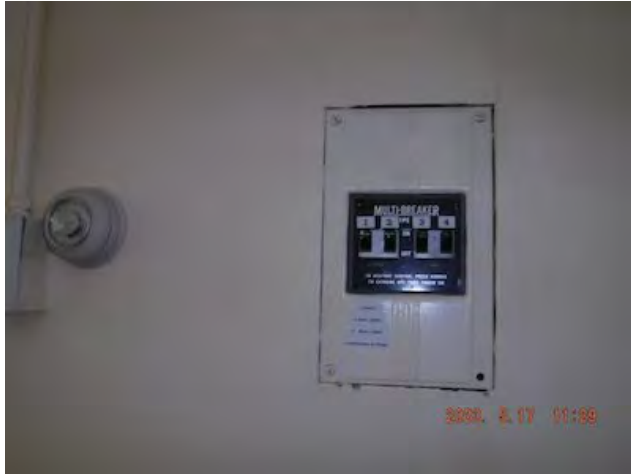
There are extremely outdated circuit breaker panels on the right and middle walls and we recommend these panels be replaced now. One is shown below.

There are extremely outdated circuit breaker panels on the right and middle walls and we recommend these panels be replaced now.

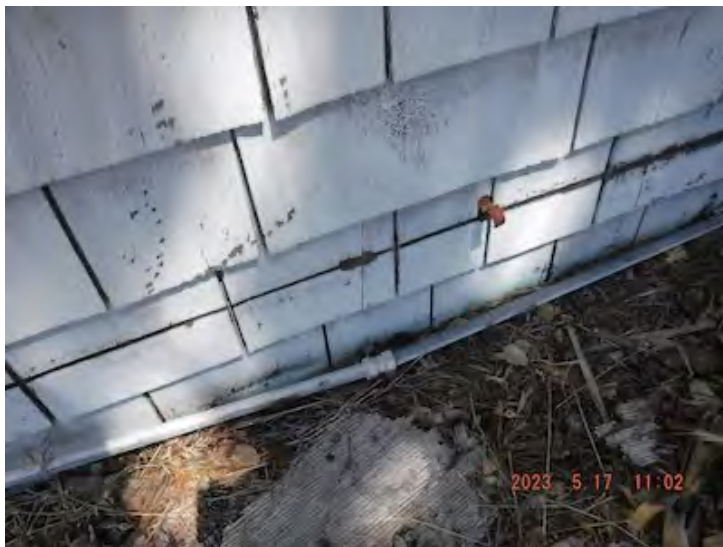
There is loose conduit in several places, and we recommend this wiring be repaired or replaced.

There is loose conduit in several places and we recommend this wiring be repaired or replaced.

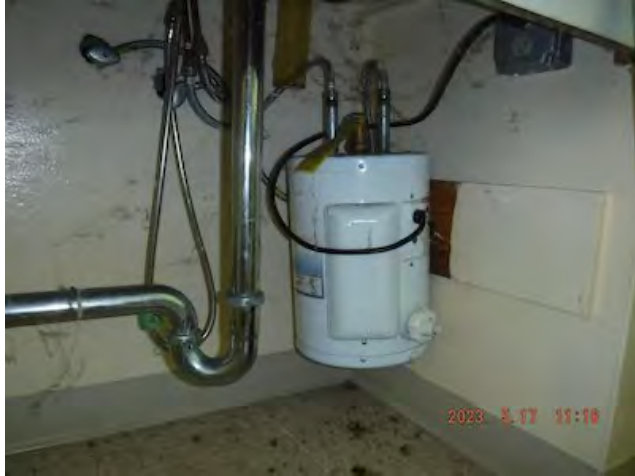
There is a 2½-gallon electric water heater below the sink in the large room at the left.

There was no hot water at the time of our inspection. The water heater was plugged into an operating electrical outlet and so is likely to have failed.

The water heater is 20 years old; it is in poor condition and we recommend it be replaced.

The water heater is 20 years old; it is in poor condition and we recommend it be replaced.

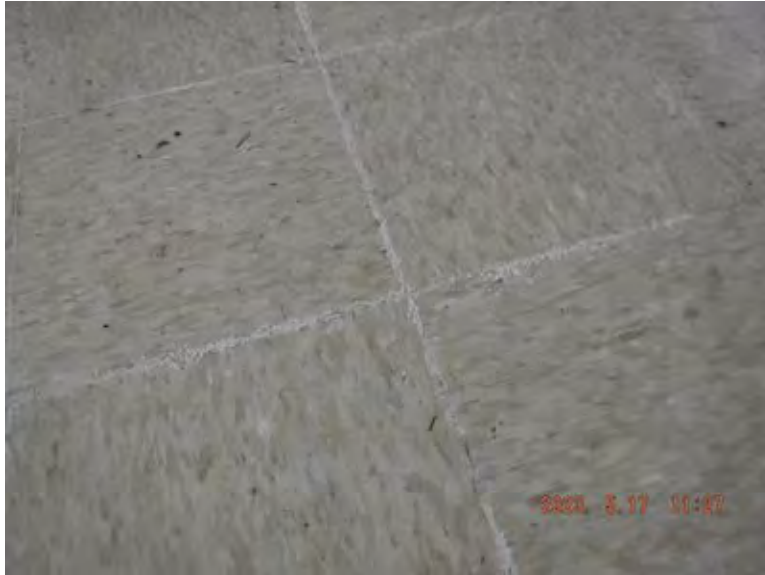
We observed efflorescence on the VCT (vinyl composition tile) flooring.

Efflorescence is a white powdery deposit which occurs on masonry or concrete. Efflorescence indicates the presence of moisture in contact with the masonry or concrete. Minor efflorescence is common even in new construction. Substantial efflorescence indicates a defective drainage condition.

We recommend these floors be removed and replaced after the flooring has been inspected and suitably sealed using a properly rated sealant. Sealants should be selected, in part, based on what is to be installed over them. A good choice for replacement may be vinyl plank, if this is compatible with future anticipated use of the space. (e.g. This would not be a good choice if very hot items may be dropped or fall in the space as in glass blowing, ceramics, etc.)

We recommend all of the concrete floors be sealed and a drainage system be installed to aid in addressing the signs of moisture in the slab as well as surface flooding.

We recommend all of the concrete floors be sealed and a drainage system be installed.
