Subject: Housing for the KPPCSD

**Kensington Park Buildings  
Master Plan  
Kensington, CA**

**March 8, 2012**

# WOOD DESTROYING PESTS AND ORGANISMS INSPECTION REPORT

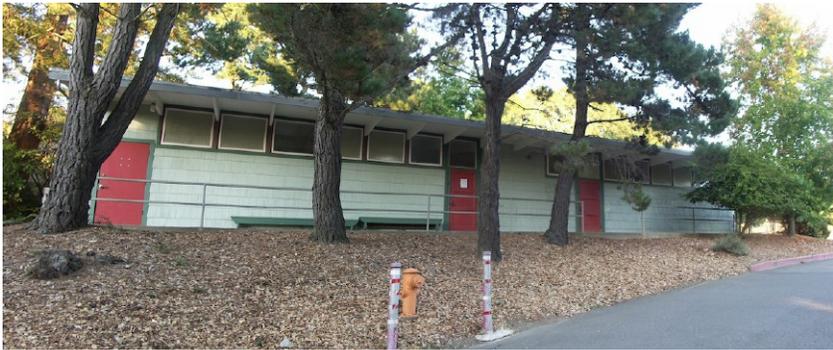
Front of Annex with covered porch, as seen from parking lot.

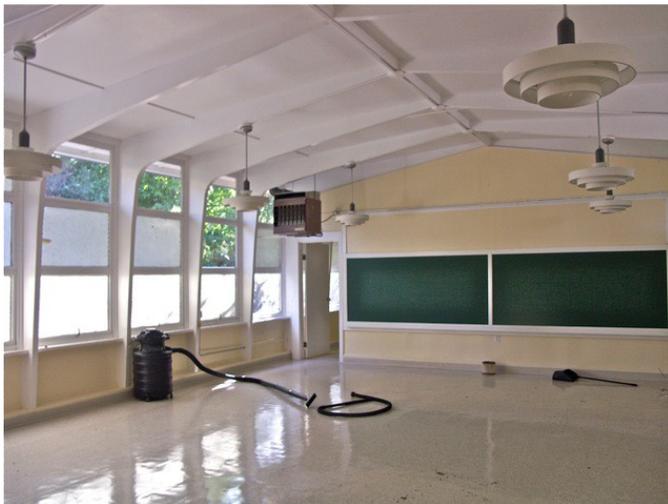
Annex interior, with painted wood arches. Large windows face east; high windows face the covered walkway.

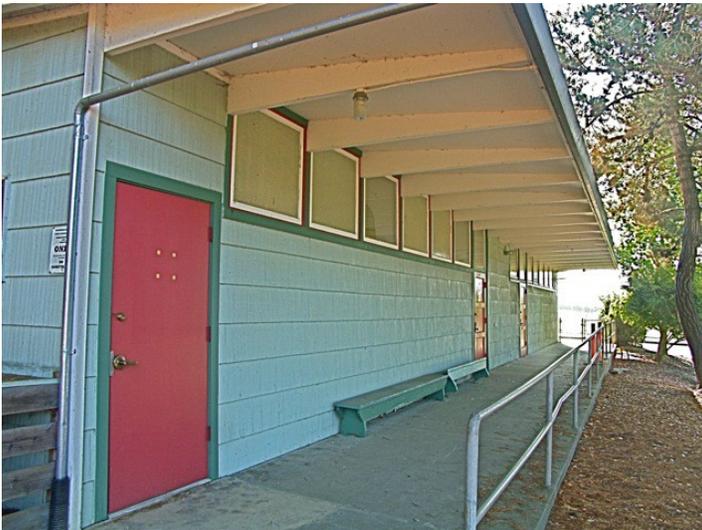
*Above: The front porch. The closest door gives direct access to a bathroom.*

The slab on grade interior floor is not noticeably cracked or out of level. The porch slab (under the overhang), however, is tilted, cracked, and pulling away from the building. This causes a problem for wheelchair access to the main entrances to the building. Since the slab has settled, it could be repaired by pouring a new topping slab to make it match the level of the slab inside, with a 1% slope away from the building for drainage.

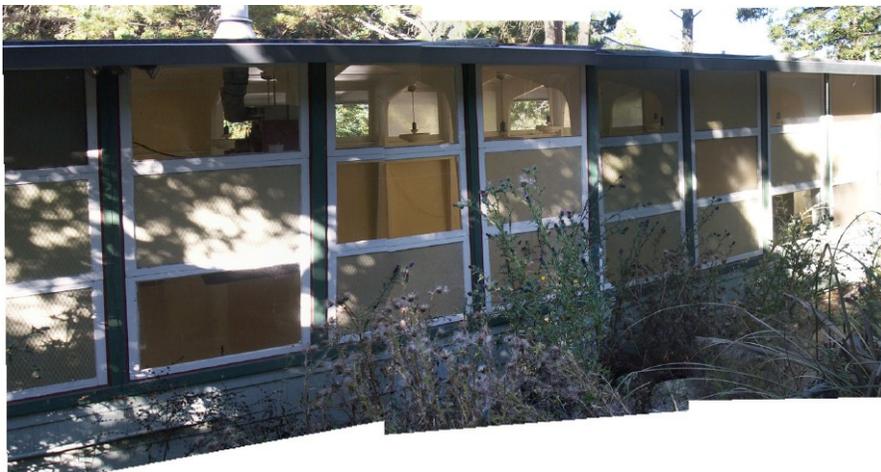
*Below: View from the back yard, showing variety of types of glazing.*

The existing window glazing is a seemingly random combination of clear glass and patterned glazing. Aesthetics will be improved by replacing all the glass with clear glazing.

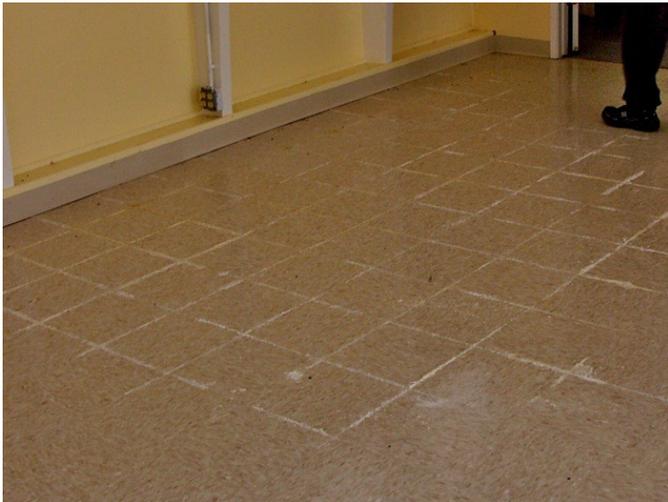
**Drainage:** Various problems have been noted with the drainage on the uphill side of the building. Water comes down the hillside and must be led away by the underground drains around the building foundation that were installed (?) about 10 years ago. These drains, assuming they exist, are apparently clogged or overloaded, since water was noted seeping through the floor slab after a rainstorm in September 2011. A retaining wall at the existing back yard fence line, with drainage above it, could help to divert the hillside water before it gets to the building drain.

*Above: Aftermath of water intrusion, winter 2011.*

There is also a downspout at the NE corner of the building that is not connected to the building drain that could contribute to the problem.

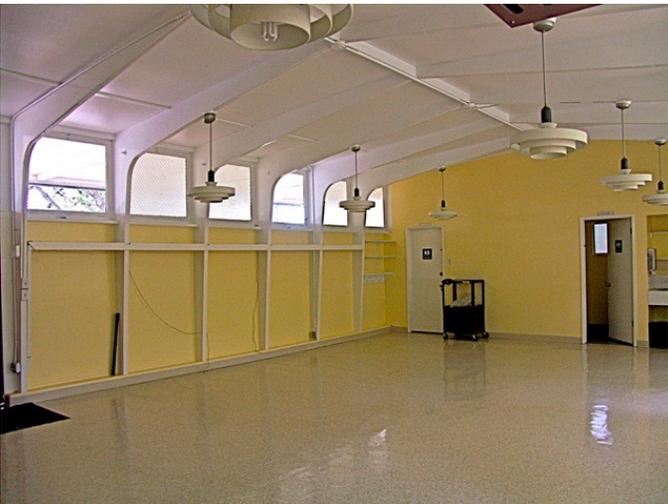
*Below: Single-wall construction. Insulated stud walls could be added between the existing arches.*

**Remodel or tear-down?** If the building is to have a major remodel, the value of the current building is that it provides a foundation, floor slab, and structural shell that could be used as a framework for new construction. Studs, insulation, electrical wiring, etc. can be added between the existing wood arches to make a more permanent and energy-efficient building.

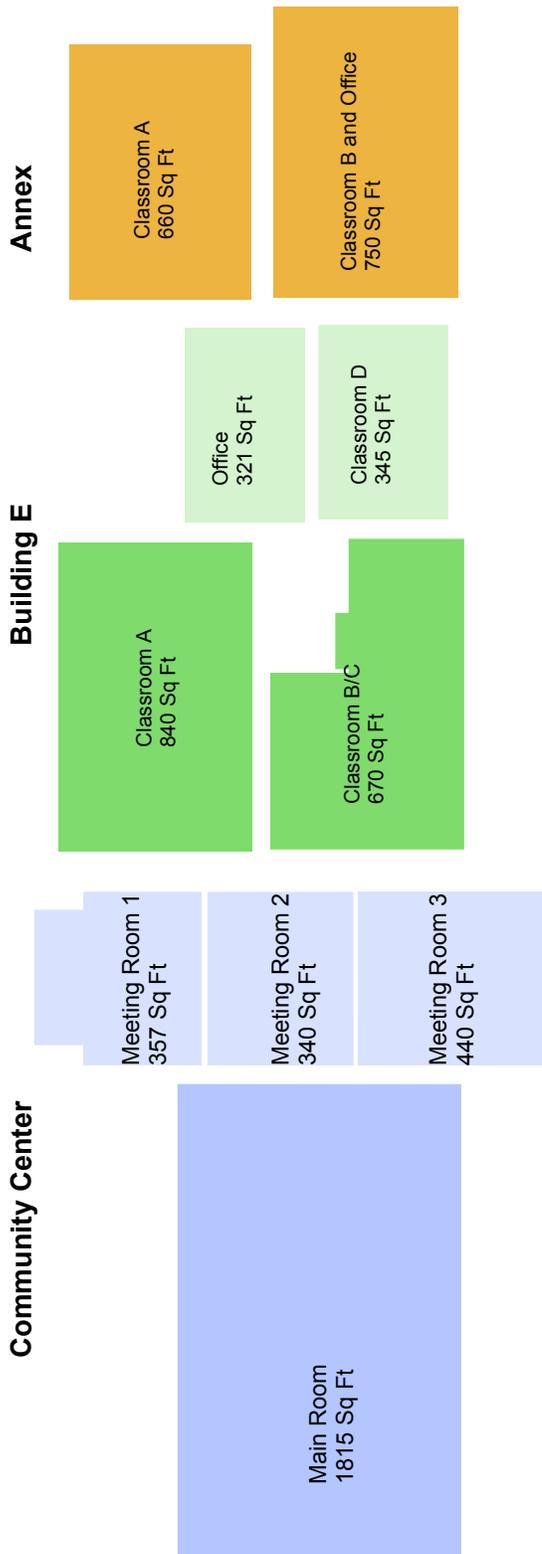
## Room Size Diagram

The diagram at left illustrates the relative sizes of the meeting and classrooms spaces available in each of the park buildings. The rectangle for each room represents the actual proportions of the room as well as its relative size. Dimensions are net of closets and full height storage cabinets.

*Annex as single 1410 sq ft room compared to 1815 sq ft main room of Community Center.*
