November 15, 2023
P-9279, L-33224

RE: Initial Geotechnical/Geological Studies
Police Department Building Site
Kensington, California

SITE PLAN

POLICE DEPARTMENT BUILDING SITE
Kensington, California

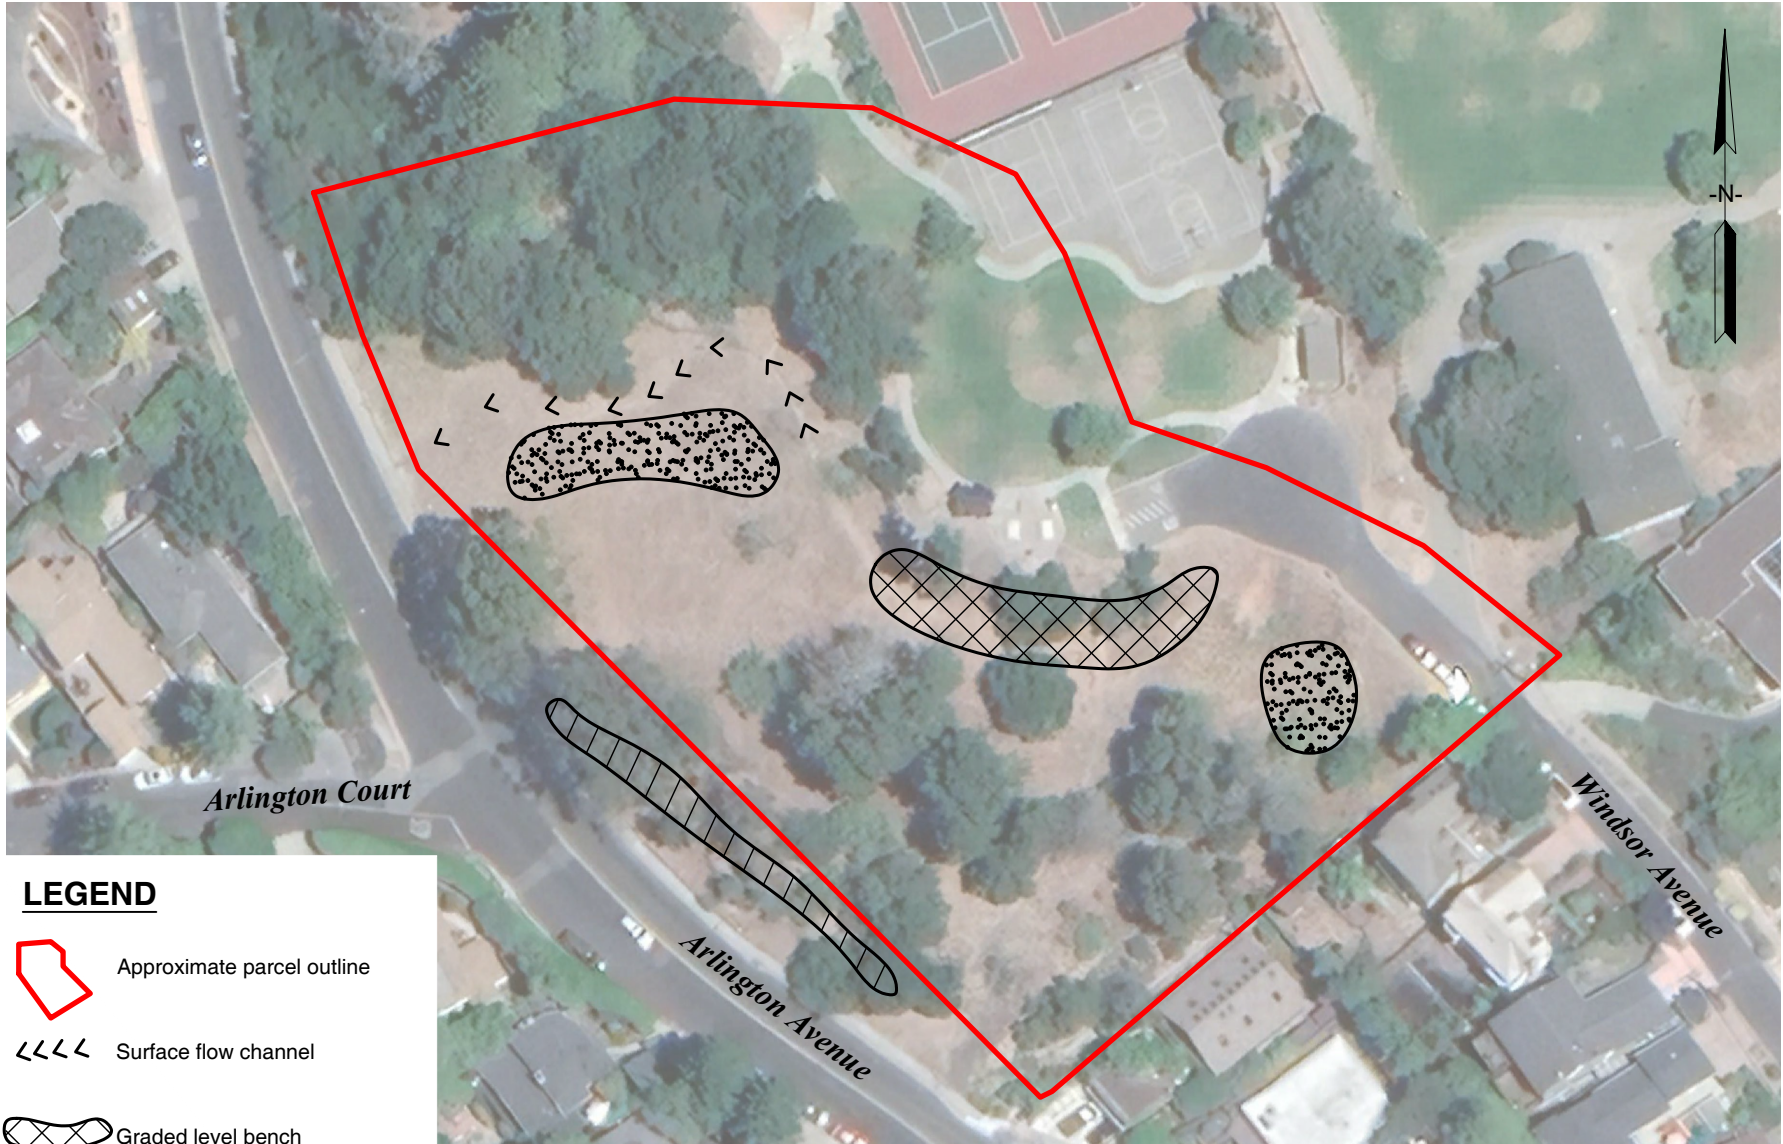
FIGURE **1**

We recently visited the site and observed the surficial characteristics of the property. The site is irregular in shape and the terrain on the property is quite variable. There has clearly been past grading over much of the site, probably related to Kensington Park and past site uses. Level areas for recreational courts, lawns, playgrounds, and picnic areas are present along the northeastern boundary of the site. A broad, undeveloped, graded level bench area is present on the site just downhill of the level picnic and pavement area. We noted a pipe present near the center of the site which discharges water from the upper-level areas; this leads to a surface flow channel which crosses the site to carry surface water westerly down to an inlet by the Arlington Avenue sidewalk. A broad area of high moisture (with green vegetation amidst the brown dry native grasses) is present immediately south of the flow channel. A second area of high moisture was observed in the eastern corner of the site.

Cut slopes are present along the southwestern boundary of the subject site just uphill of the Arlington Avenue sidewalk. Bedrock outcrops are present throughout these cut slopes, and some raveling of the bedrock materials was noted but no significant instabilities. Although there were some uneven portions of the site, it appears these features are primarily related to past grading activities, and not to landsliding.

Locations of some of the key surface features we observed at the site are presented on the Site Plan (Figure 1).

The site currently has mild to moderate slopes present, and grading will be necessary to develop the proposed facilities. Because the site generally contains shallow soils over strong bedrock, normal grading practices can be used and should perform well. Some remedial grading of existing fill from old grading activities may be necessary to stabilize such areas where concerns exist regarding future stability.

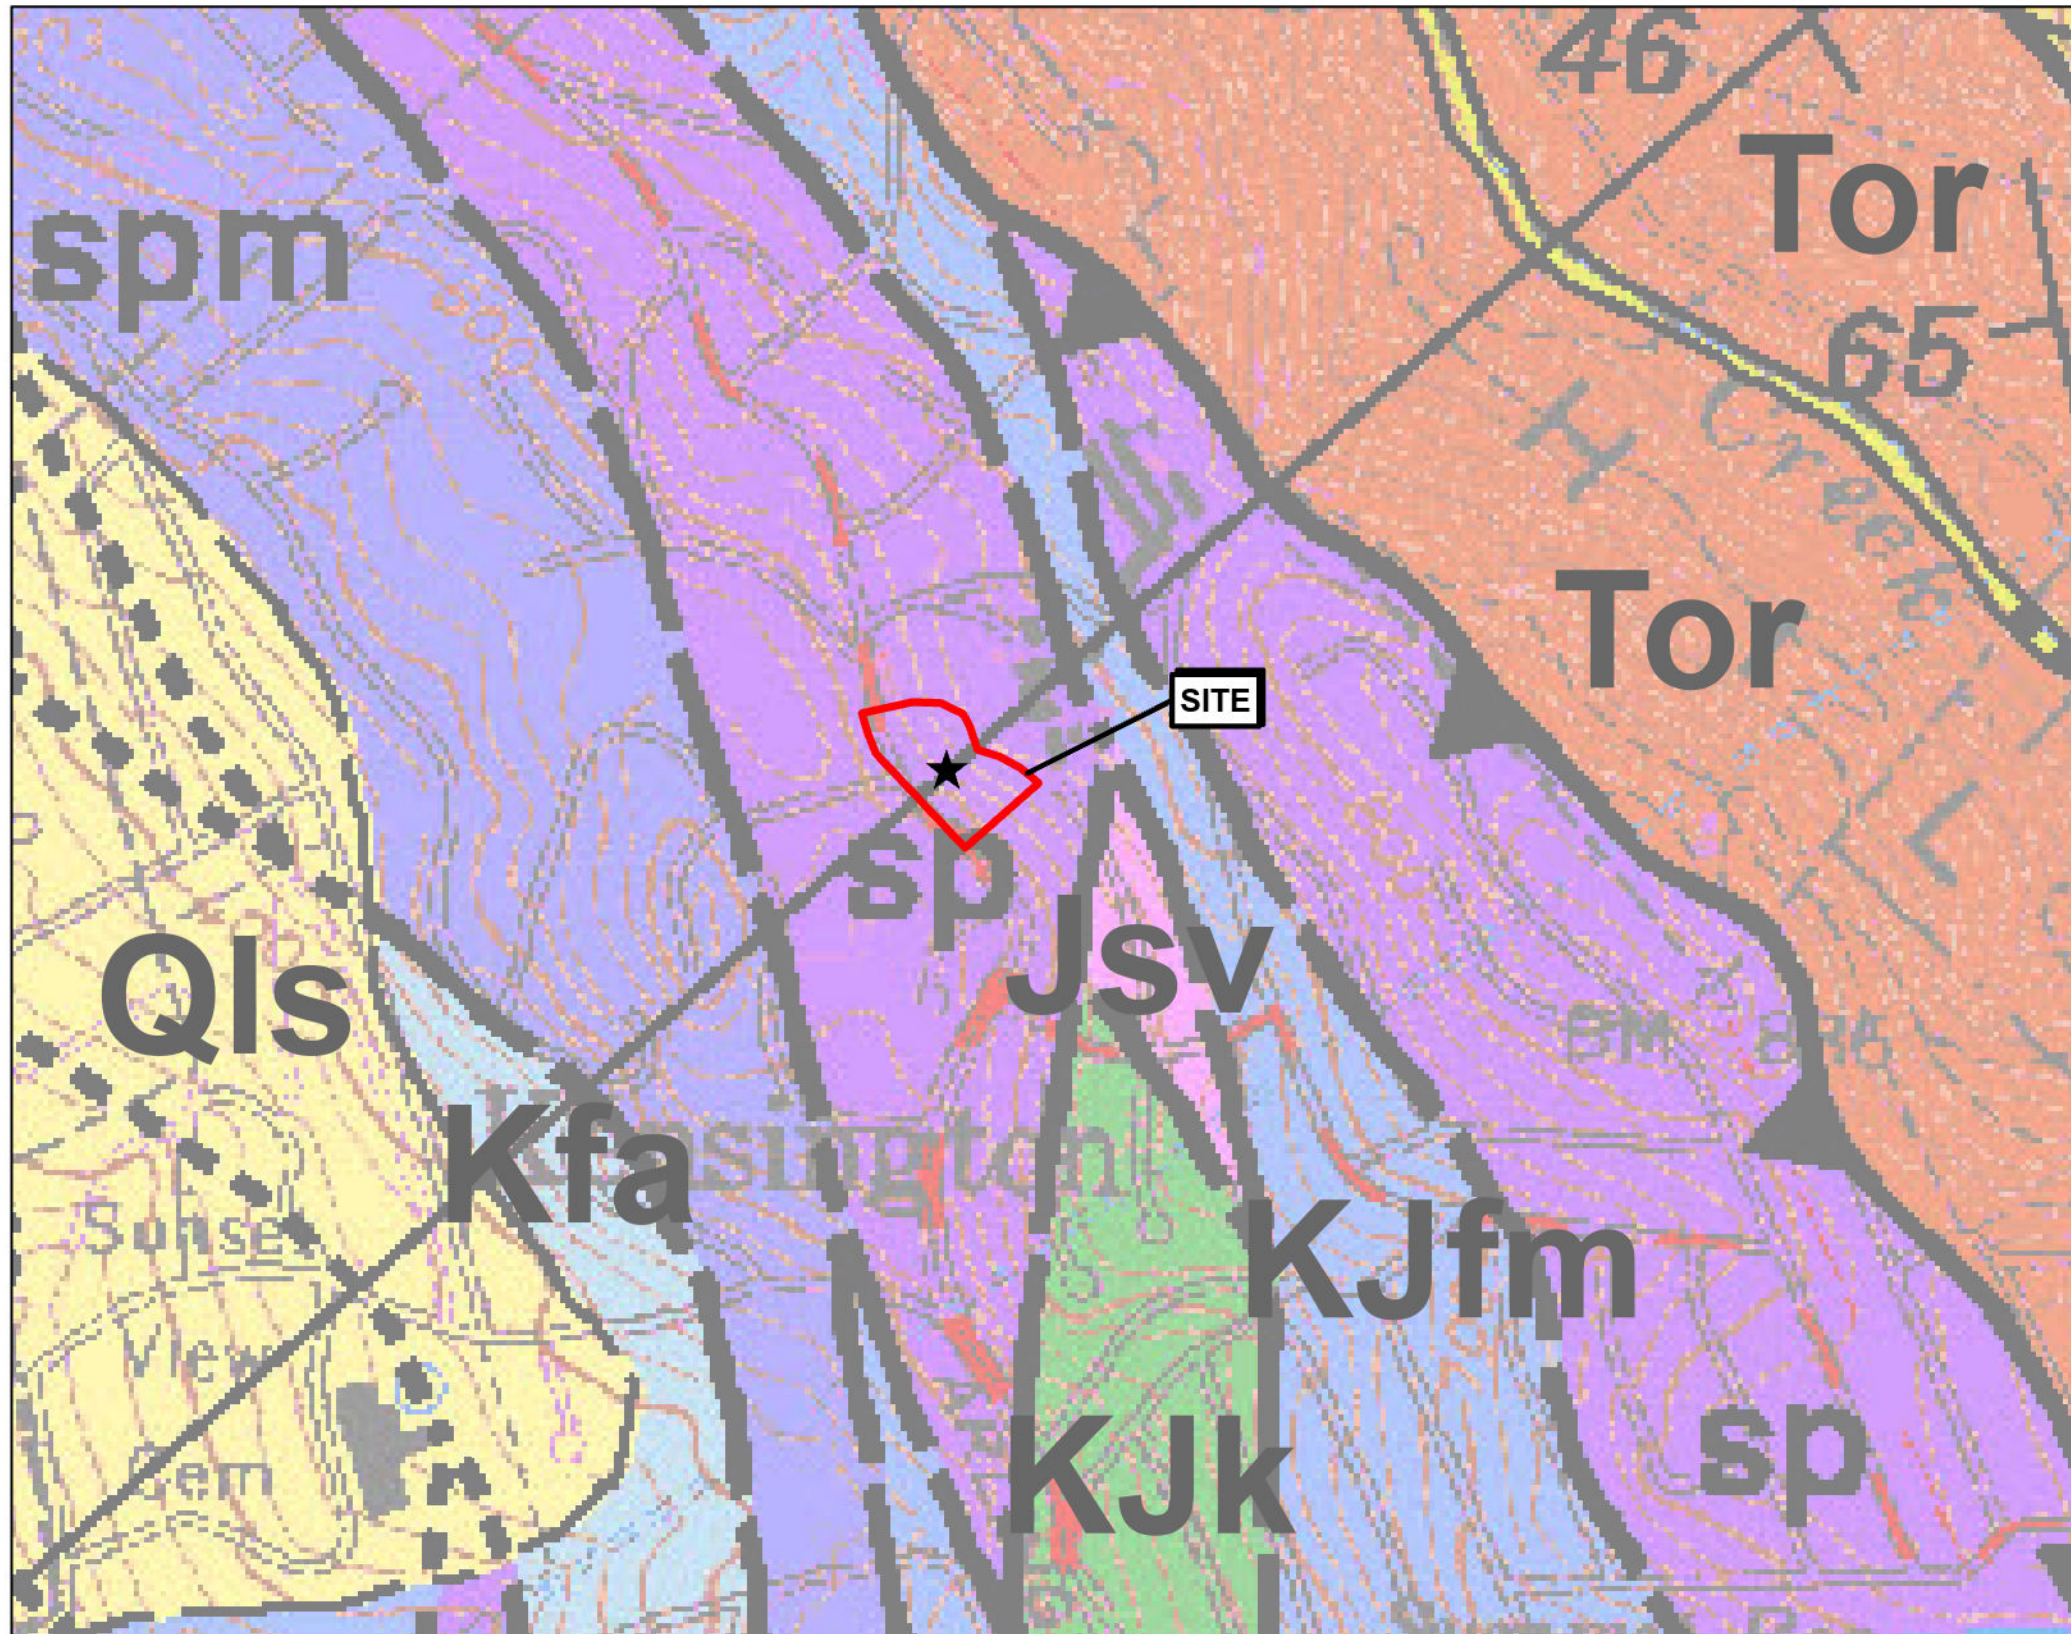
GEOLOGIC MAP

A geologic map of the area (Graymer, 2000) indicates that the site is locally within a complex geologic environment of many of the bedrock units described above. A copy of the portion of the Graymer map that includes the site is presented as Figure 2, Geologic Map. This figure illustrates that the Graymer maps the site as underlain by serpentinite (sp), a unit within the Franciscan Assemblage. Nearby, volcanic keratophyre bedrock (Jsv, belonging to the Coast Range Ophiolite), as well as sedimentary bedrock of the Knoxville Formation (KJk, part of the Great Valley Sequence) and mélange units associated with the Franciscan Assemblage are all present.

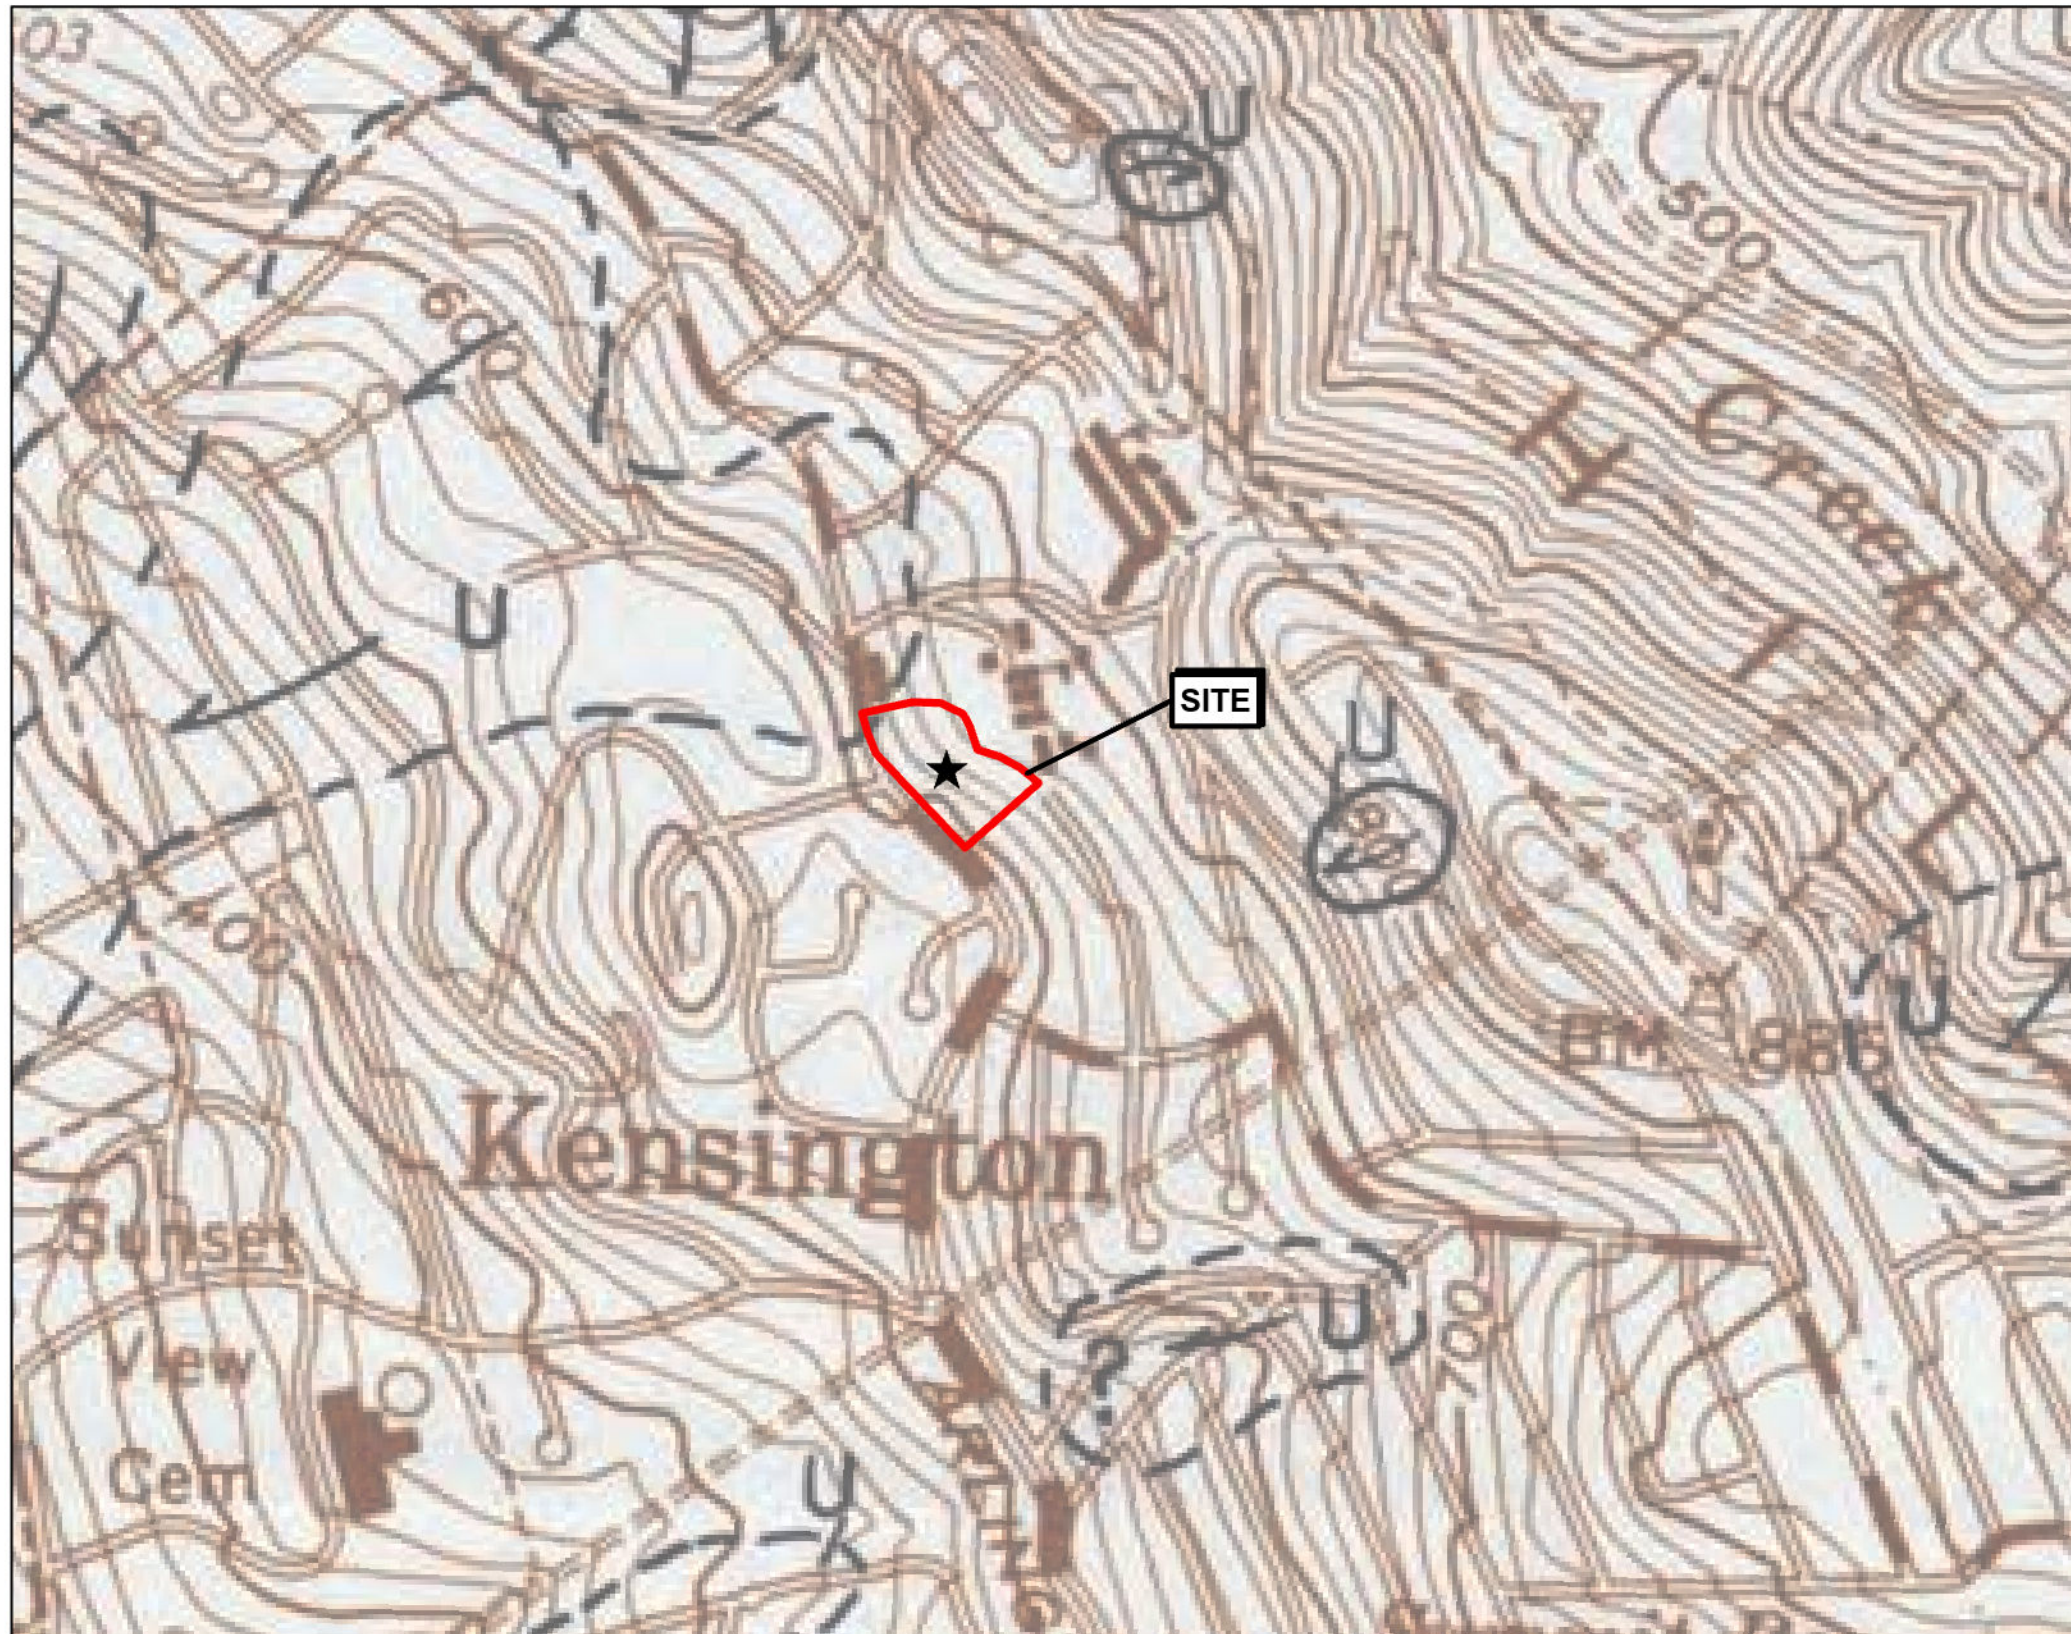
LANDSLIDE MAP 2

Kensington area. A copy of the portion of the CDMG map of this area from their 1973 publication is presented as Figure 4, Landslide Map 2. This map indicates the large Blakemont landslide is immediately adjacent to the northwest corner of the site (but does not encroach into it), and a very small landslide deposit is present about 1,000 feet east of the site.

Based on our review of published literature and our site observations, it is our opinion there is a low likelihood of significant landslides being present at the site. The natural setting is one of relatively strong bedrock units that are not highly susceptible to landsliding. The most reliable landslide map of the area (CDMG, 1973) does not indicate any landslides are present on the property. No dramatic landforms were noted during our site reconnaissance that seemed to be indicative of ground instability. The raveling of the bedrock we observed in cut slopes along Arlington Avenue is largely an erosional process and not a sign of landslide-type instability. However, it should be noted that past grading may have resulted in the placement of potentially unstable fill materials on the property, particularly where the undeveloped, graded bench is present.

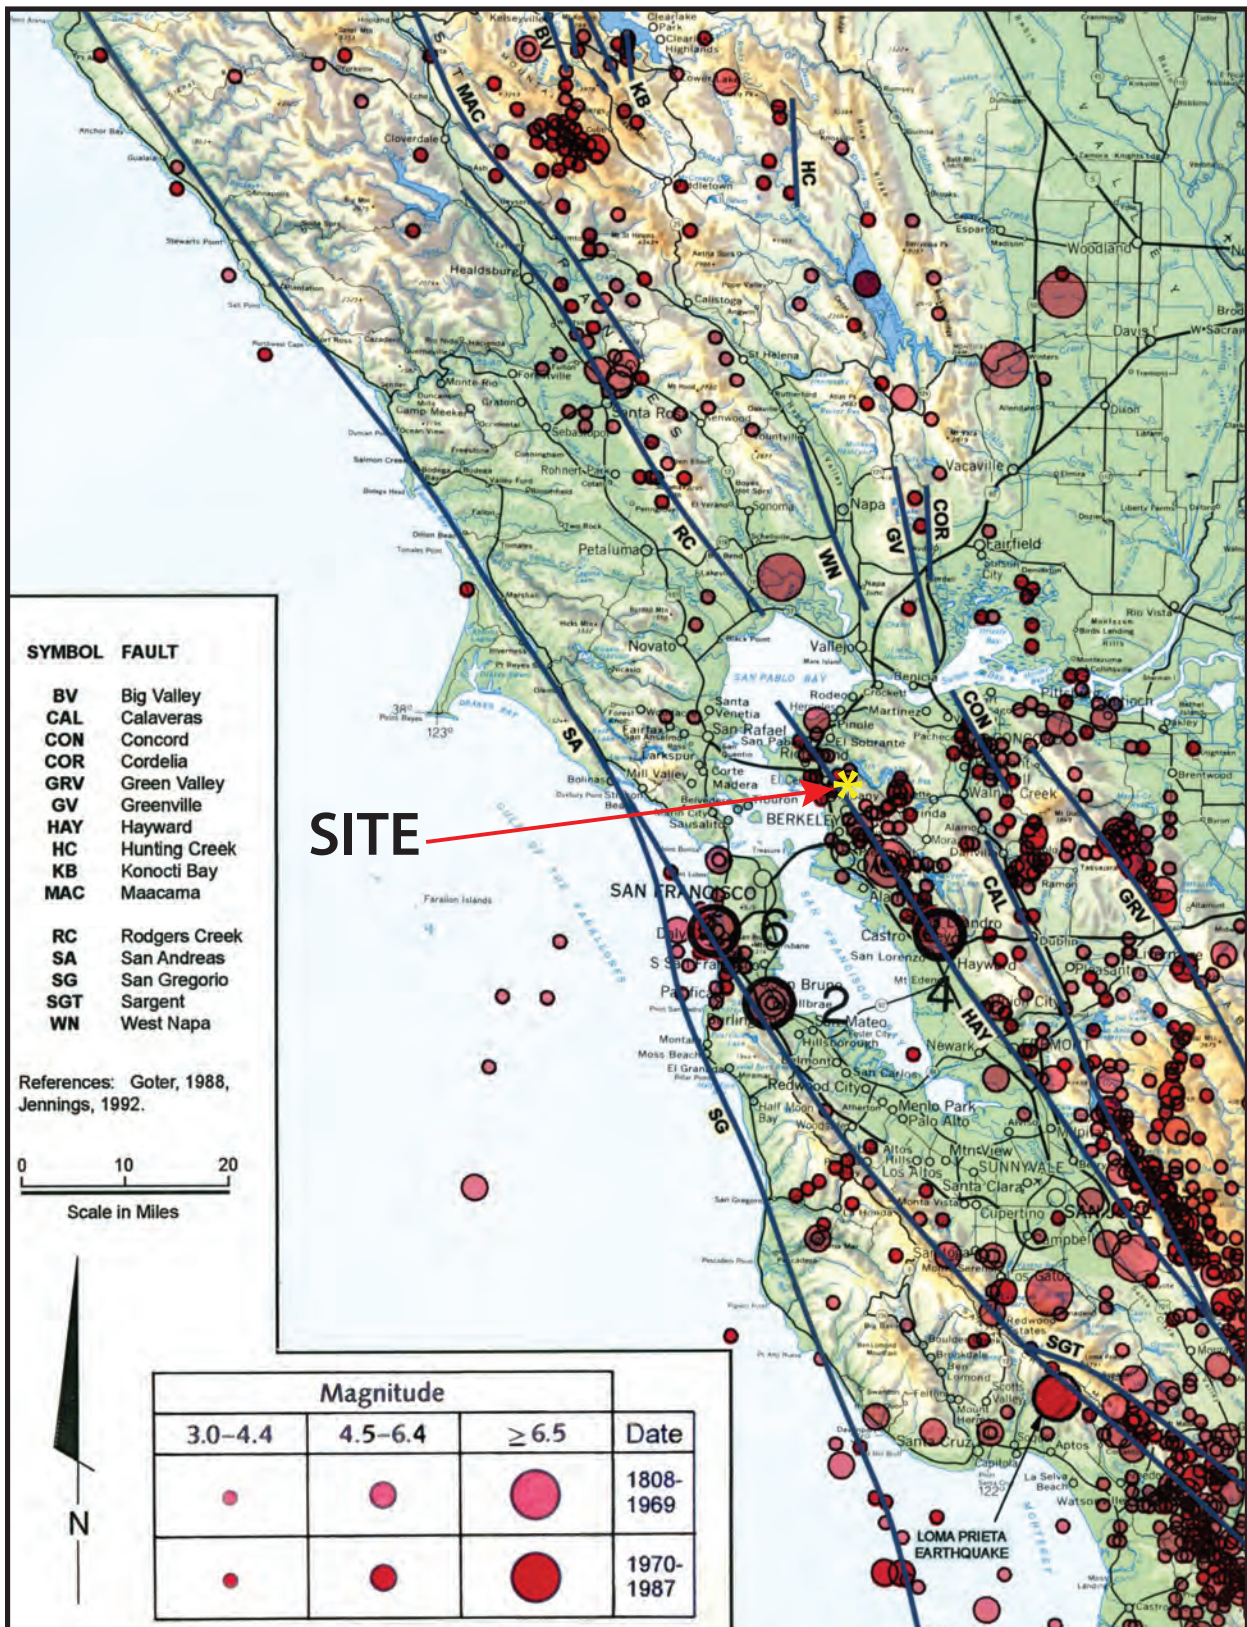
REGIONAL ACTIVE FAULT MAP

Seismic activity within the northern Coast Ranges is generally associated with active faults belonging to the San Andreas system of faults, including major active structures both east and west of the site. The principal active faults in the region are the Hayward-Rodgers Creek fault, mapped approximately 300 feet southwest of the site; the San Andreas fault, 18.5 miles to the west; and the Calaveras fault, 13 miles to the southeast. Other major active faults in the region include the San Gregorio fault, approximately 21.5 miles to the west; the Greenville fault, 18.5 miles east; the Concord-Green Valley fault, 14 miles northeast; and the West Napa fault, 18.5 miles northeast (Jennings and Bryant, 2010). Table 1 summarizes the fault parameters of selected known active faults closest to the site and Figure 5, Regional Active Fault Map provides locations of the key faults:

Fault	Distance and Direction from Site ¹	Maximum Moment Magnitude
Hayward-Rodgers Creek	300 feet southwest	7.6
Calaveras (north of Calaveras Reservoir)	13 miles southeast	6.8
Concord-Green Valley	14 miles northeast	6.9
San Andreas (1906 rupture)	18.5 miles west	7.9
San Gregorio	21.5 miles west	7.3
Greenville	18.5 miles east	6.9
West Napa	18.5 miles northeast	6.5

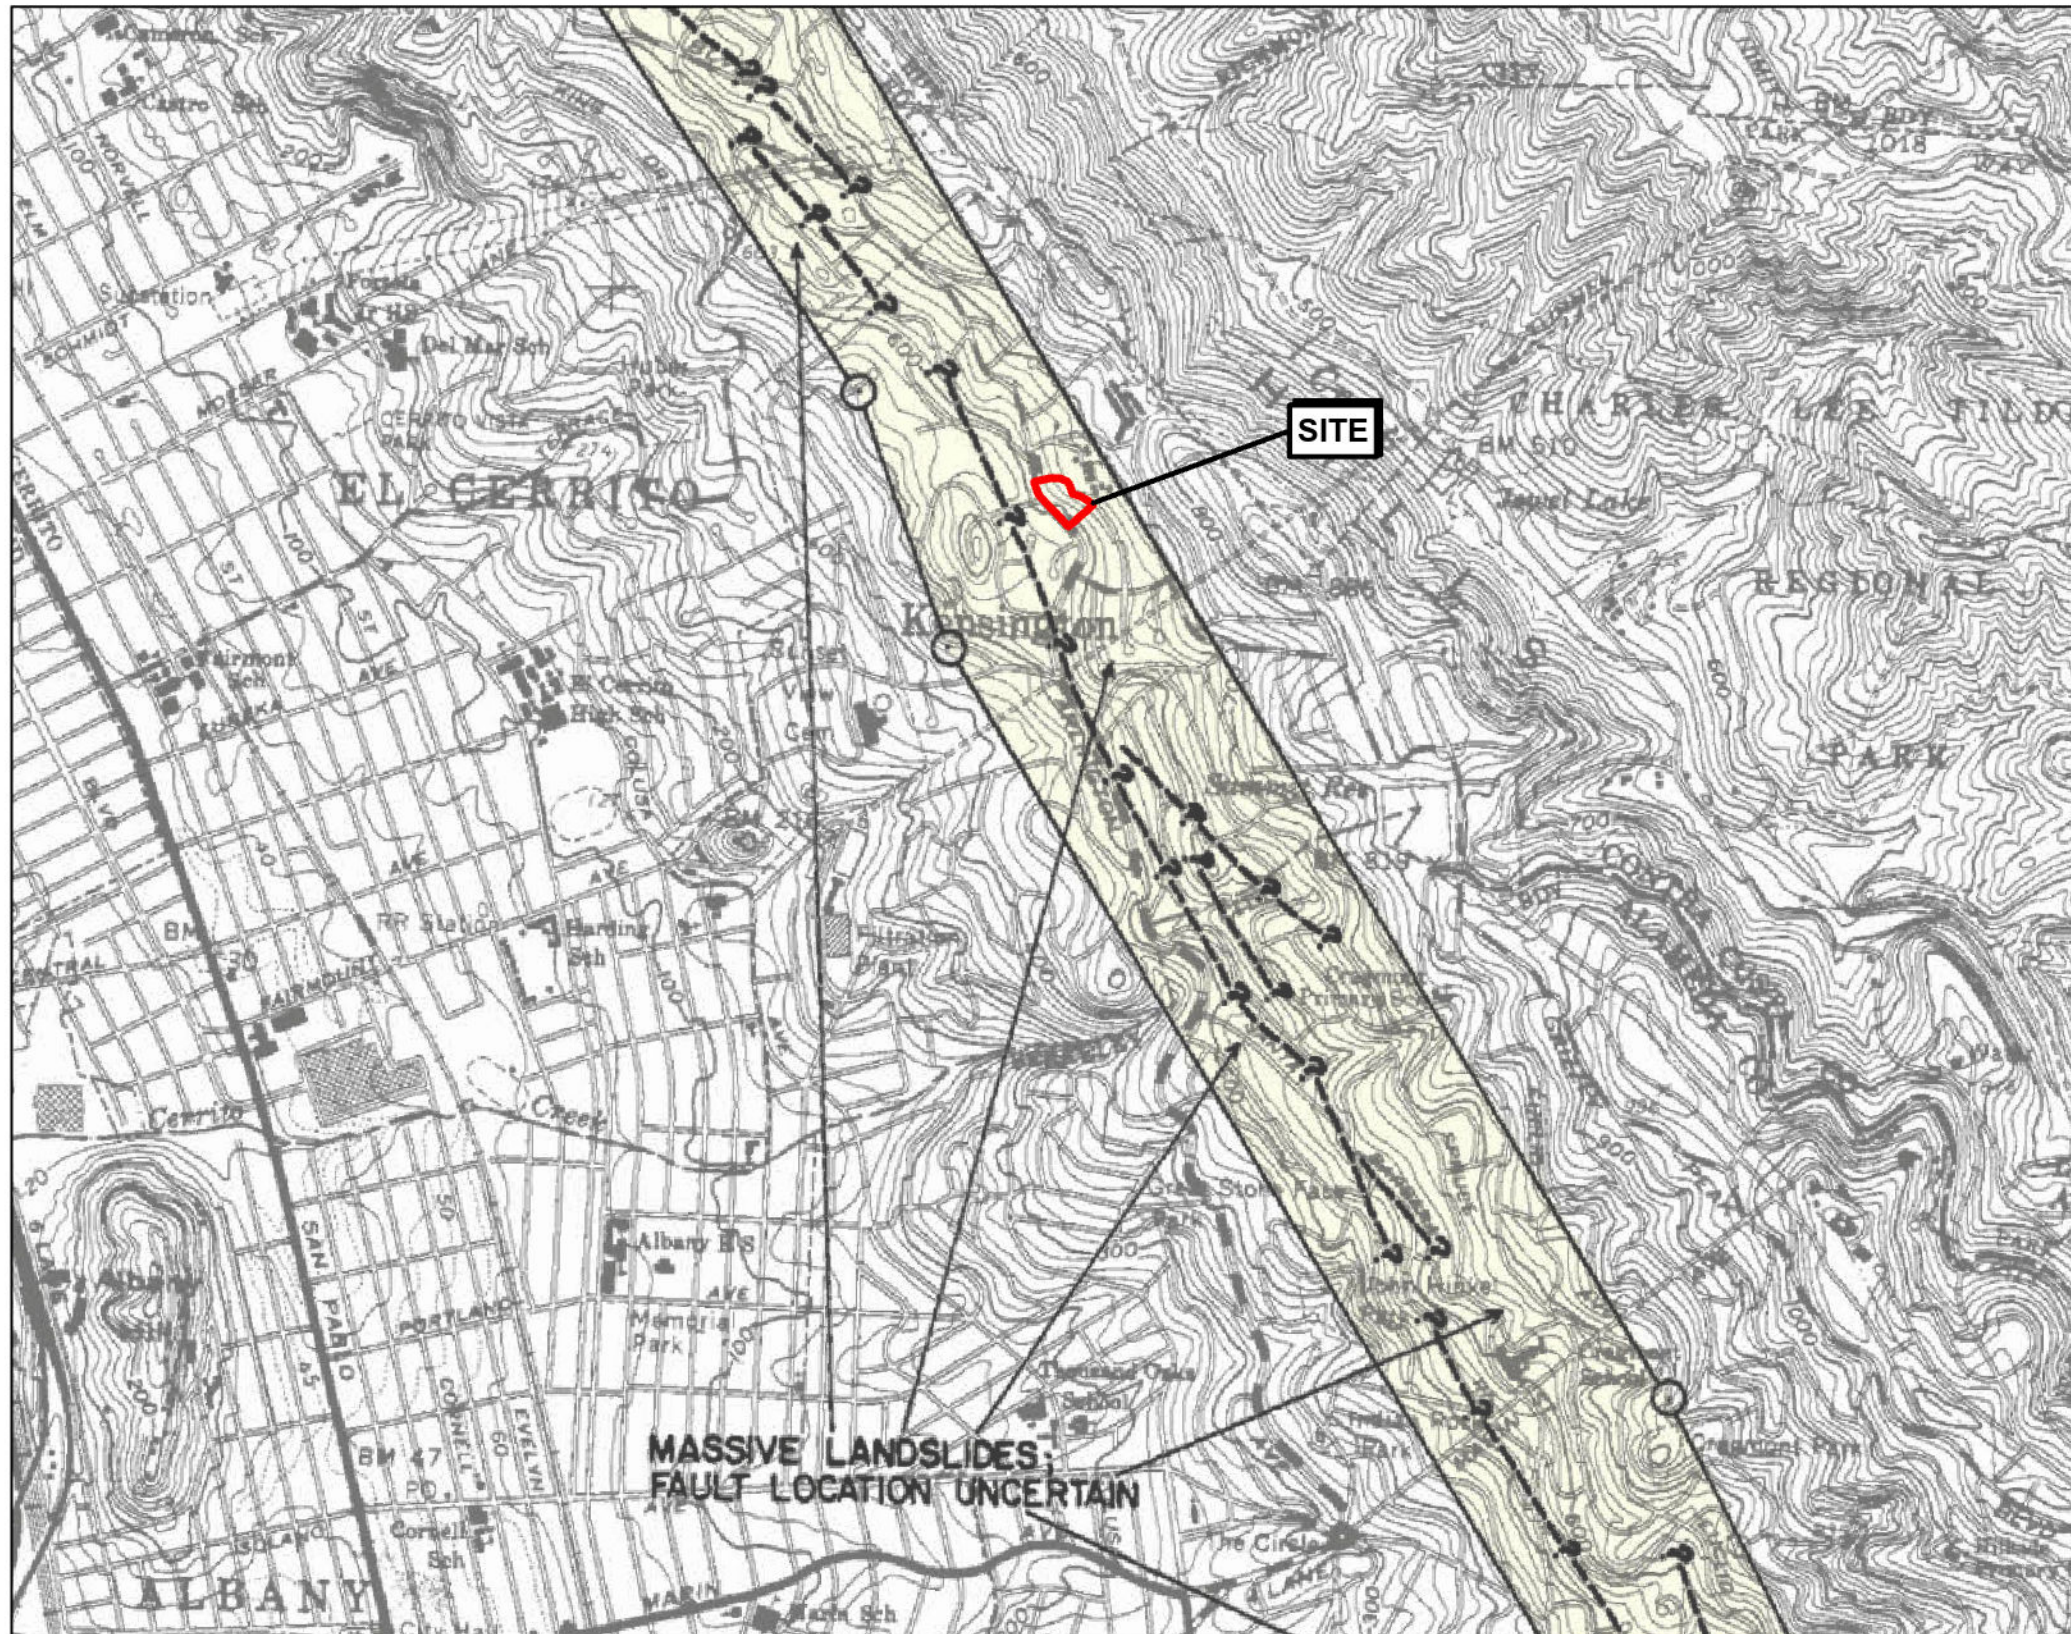
ALQUIST PRIOLO EARTHQUAKE FAULT ZONE MAP

The nearest active trace of the Hayward-Rodgers Creek fault is mapped approximately 300 feet southwest of the site (California Geological Survey, 1982; and Lienkaemper, 1992). The site is located within the Alquist-Priolo Earthquake Fault Zone (APEFZ) established by the State of California around the Hayward-Rodgers Creek fault. The mapped fault location and the limits of the APEFZ in the area are presented on Figure 6, Alquist-Priolo Earthquake Fault Zone Map.

The site is located within the Alquist-Priolo Earthquake Fault Zone (APEFZ) established by the State of California around the Hayward-Rodgers Creek fault. However, all of the data we reviewed indicates the active trace(s) of the Hayward-Rodgers Creek fault pass about 300 feet southwest of the project site.

Therefore, we conclude the site has a low likelihood for fault rupture during future earthquakes. Nonetheless, if the project proceeds, a detailed fault study of the site will need to be performed because the site is located within an APEFZ, and because police department usage makes the development a critical facility.

When plans for the proposed police facilities are created, a detailed geotechnical/geologic investigation of the site should be performed. This will include geotechnical engineering and geologic components. A fault rupture analysis will be needed to satisfy the requirements of the Alquist-Priolo Earthquake Fault Zone provisions. This will include fault trenching that extends at least 50 feet beyond any proposed buildings. Also, subsurface borings and laboratory testing of recovered samples will be needed to guide the development of geotechnical recommendations for site grading, building foundations, site drainage, and other details.
