KENSINGTON POLICE PROTECTION AND COMMUNITY SERVICES DISTRICT

KENSINGTON COMMUNITY CENTER
PROPOSED SEISMIC RETROFIT
59 Arlington Avenue
Kensington, CA 94707

PROJECT NARRATIVE REPORT

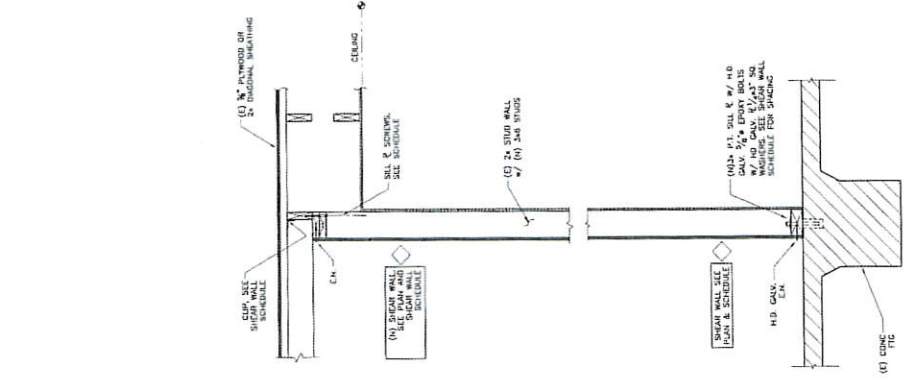
4 (N) PLYWOOD SHEAR WALL DETAIL AT (E) WALL 1" = 1'-0"

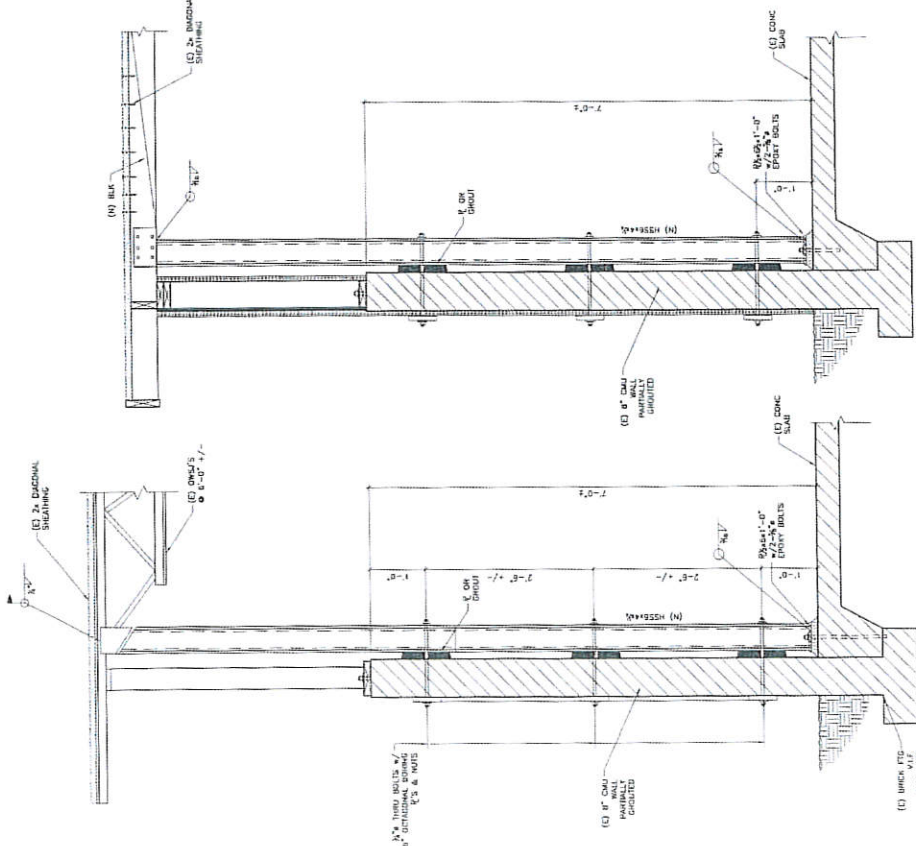
2 STEEL STRONG BACK @ (E) CMU WALL 1" = 1'-0"

1 STEEL STRONG BACK @ (E) CMU WALL 1" = 1'-0"

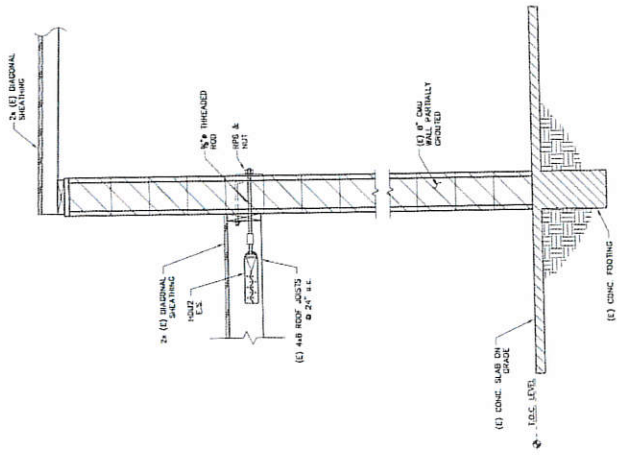
4 - CMU SEISMIC WALL TIE
UPGRADE AT LINE 5 A TO 6
1" = 1'-0"
