Kensington Park Buildings Master Plan Kensington, CA

March 8, 2012

2: Kensington Park Existing Conditions Review

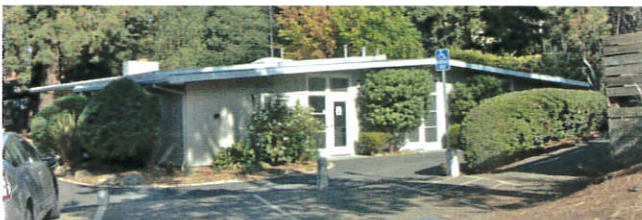
Above: Community Center exterior.

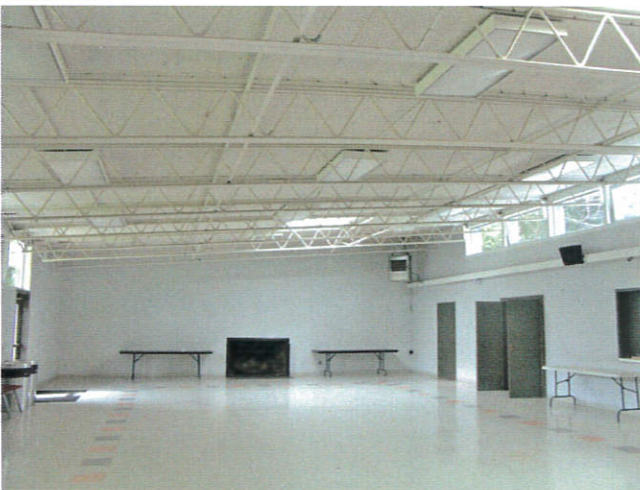
Below: Community Center Main Room, with exposed metal trusses.

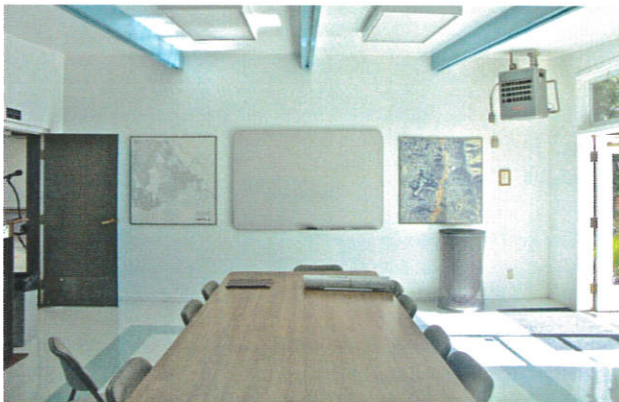
Meeting room 3. Note suspended space heater at upper right-hand corner.

The meeting rooms have no ventilation other than operable windows and doors. Rooftop or ceiling fans could improve air quality and comfort in the meeting rooms.

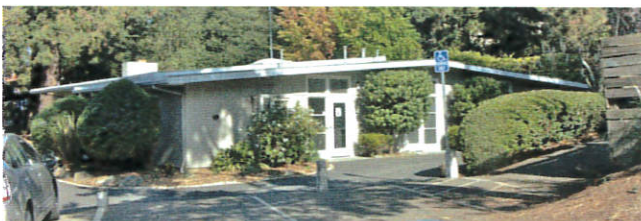
Doors to meeting rooms 2 and 3 are frequently mistaken as the main entrance to the building.

Existing doors to meeting rooms 2 and 3 face the parking lot and confuse newcomers because they look like the main entrance.

Possible solution: let them be the main entrance!

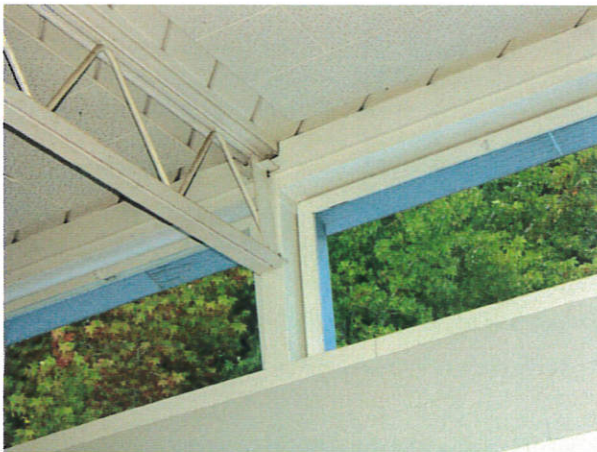
Truss support at clerestory windows.

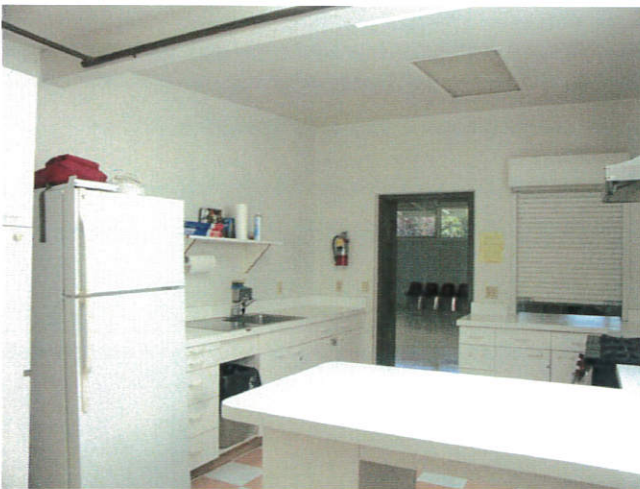
Kitchen is used for cooking classes.

1. The kitchen floor should have a seamless surface rather than the current vinyl tiles (which are cracked and broken).
2. Countertops should be stainless steel. The hood fan needs a fire extinguishing system.
3. More sanitary dish and pot washing facilities may be needed.
4. Grease traps may be required.
5. Sinks must meet the NSF sanitation standards.
6. A hand-washing sink may need to be added.
7. Since the kitchen is also used for cooking classes, some accessible features may also need to be provided.

Note that the resolution of many of these issues will depend on the exact use of the kitchen, which will need to be discussed with an experienced commercial kitchen designer and possibly with the county health department as well. The cost estimate will include an allowance for a full replacement of the kitchen to commercial kitchen standards.

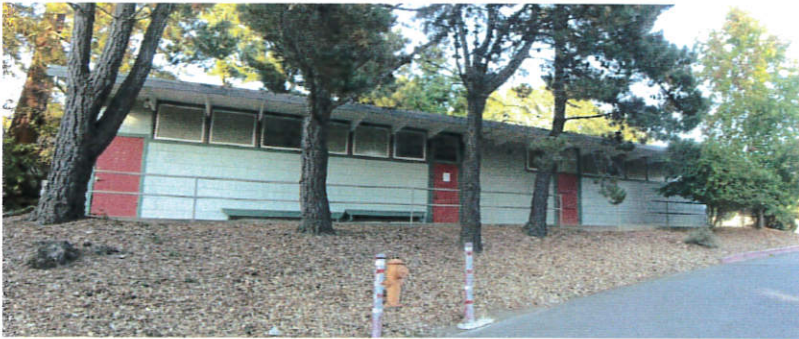
Front of Annex with covered porch, as seen from parking lot.

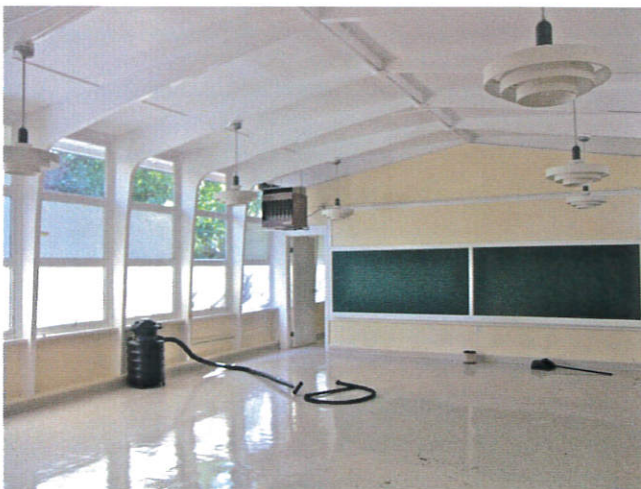
Annex interior, with painted wood arches. Large windows face east; high windows face the covered walkway.

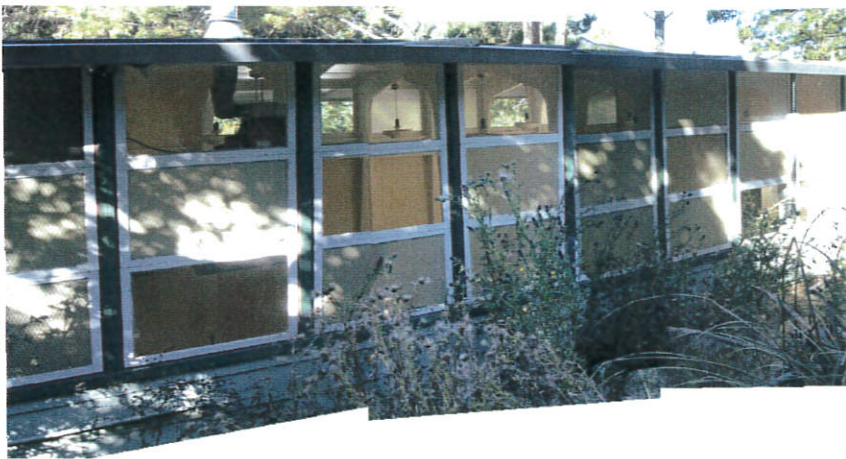
Below: View from the back yard, showing variety of types of glazing.

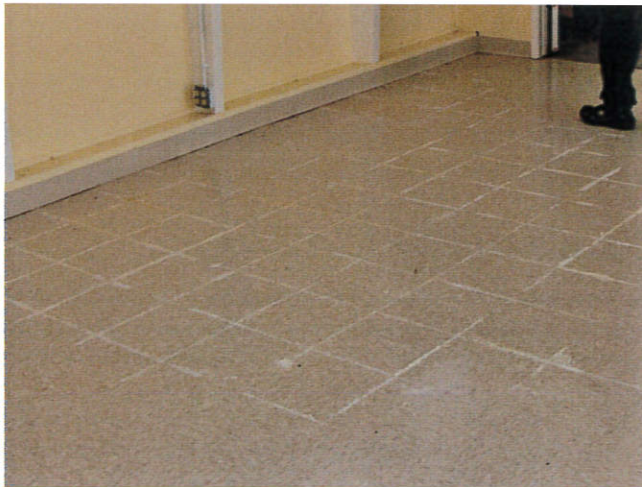
Above: Aftermath of water intrusion, winter 2011.

Drainage: Various problems have been noted with the drainage on the uphill side of the building. Water comes down the hillside and must be led away by the underground drains around the building foundation that were installed (?) about 10 years ago. These drains, assuming they exist, are apparently clogged or overloaded, since water was noted seeping through the floor slab after a rainstorm in September 2011. A retaining wall at the existing back yard fence line, with drainage above it, could help to divert the hillside water before it gets to the building drain.

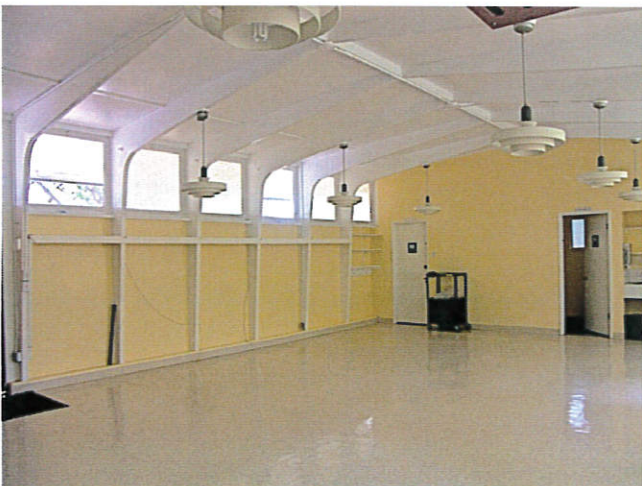
Below: Single-wall construction. Insulated stud walls could be added between the existing arches.

Remodel or tear-down? If the building is to have a major remodel, the value of the current building is that it provides a foundation, floor slab, and structural shell that could be used as a framework for new construction. Studs, insulation, electrical wiring, etc. can be added between the existing wood arches to make a more permanent and energy-efficient building.

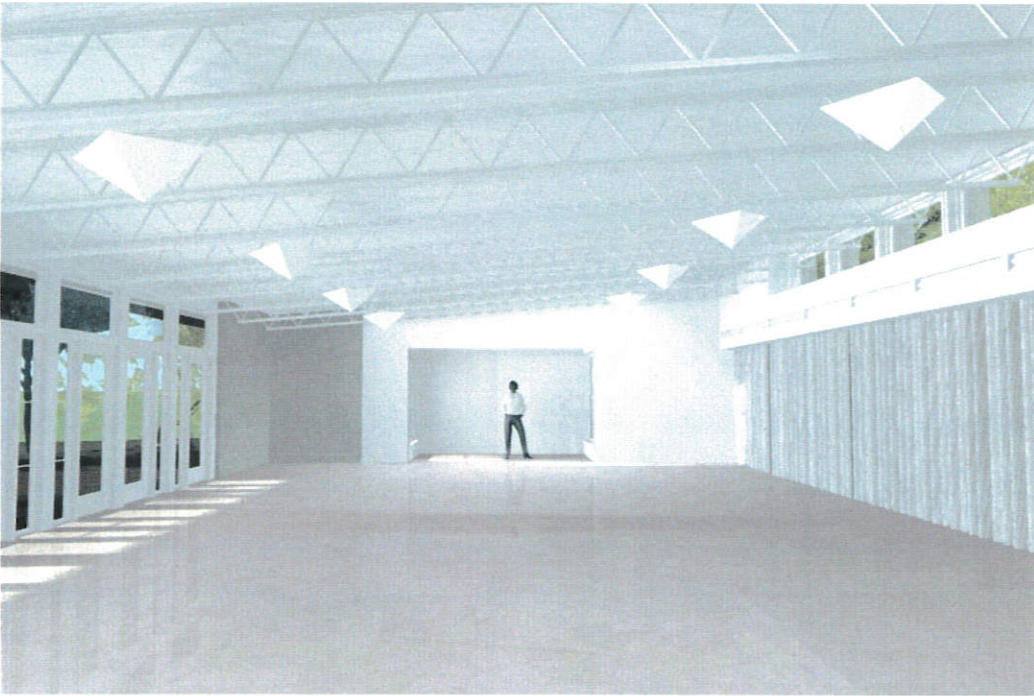
- Lights suspended below the bottom of the trusses will provide a new ceiling focus and reduce the visual dominance of the existing trusses.
- New windows or doors on the west wall give a view to the garden. Windows would allow a row of chairs against the wall below the sills. Rebuilding of this portion of the wall will remove the existing hazardous concrete block so it does not need to be braced.

- The north wall and recessed alcove behind it is the focal point of the room. The alcove could be used as a mini-stage for events, or as a place for parents to sit while watching children in a class.

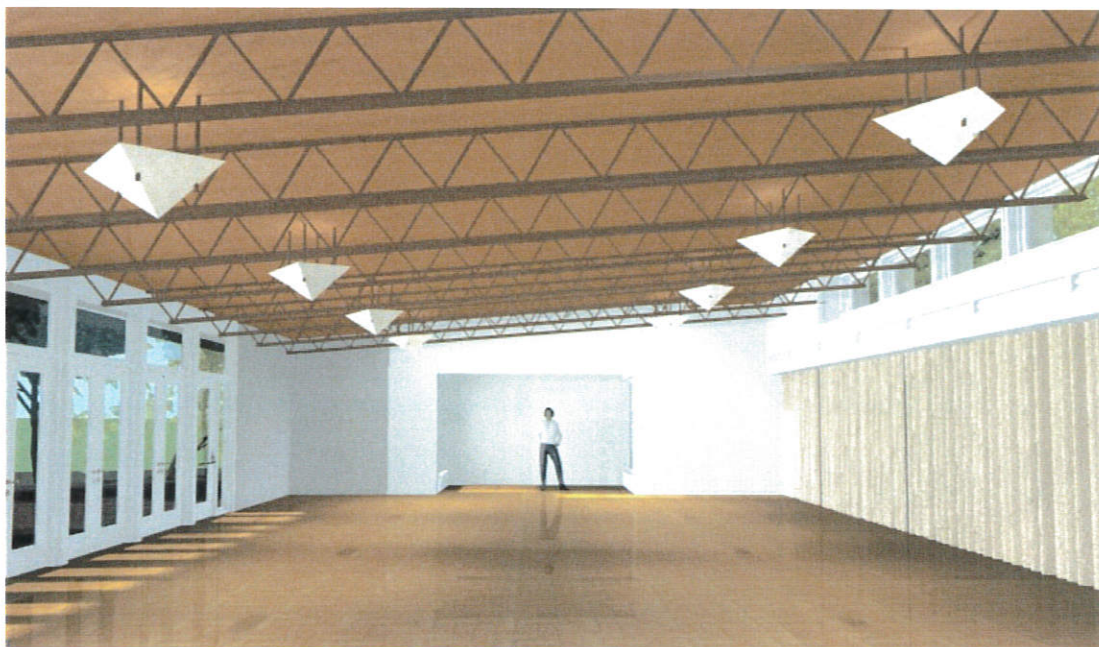
Main room with wood textured floor and ceiling.

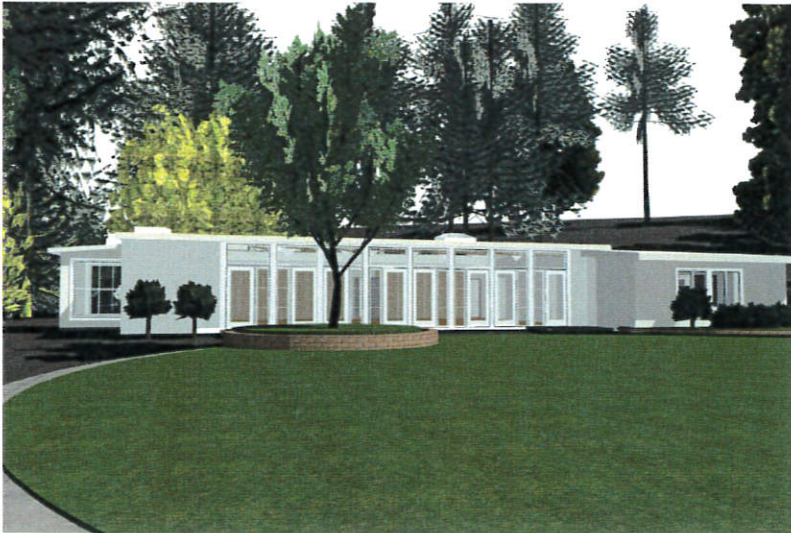
Exterior showing new doors in west wall and small alcove addition.

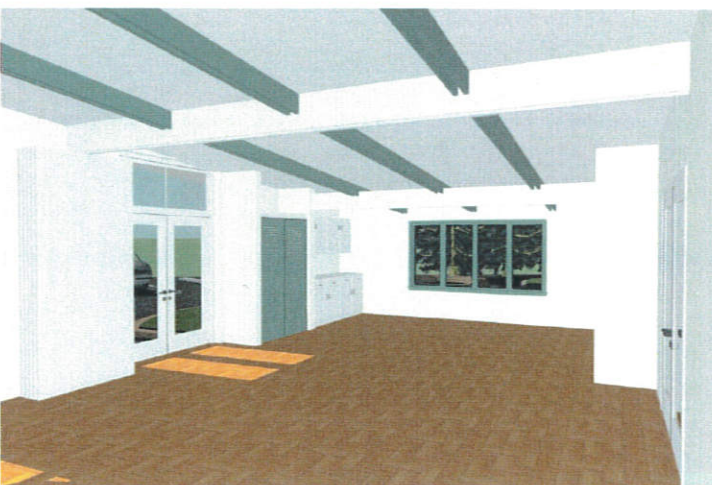
Option 2 Combined Rooms 2 and 3

Above right: combined room can function as a vestibule to the main room or as a 675 sq ft meeting room. Double doors give access to the main room, could be used for entrance for bridal procession, etc.

Left: the existing wall between rooms 2 and 3 is replaced with a beam and track mounted folding acoustical partition.
